Traffic Note Addendum

Land at Chimmens Solar Farm, Mussenden Lane.

Date: March 2024 | Pegasus Ref: P22-1221_R002 RevA_TR_AJ_JB

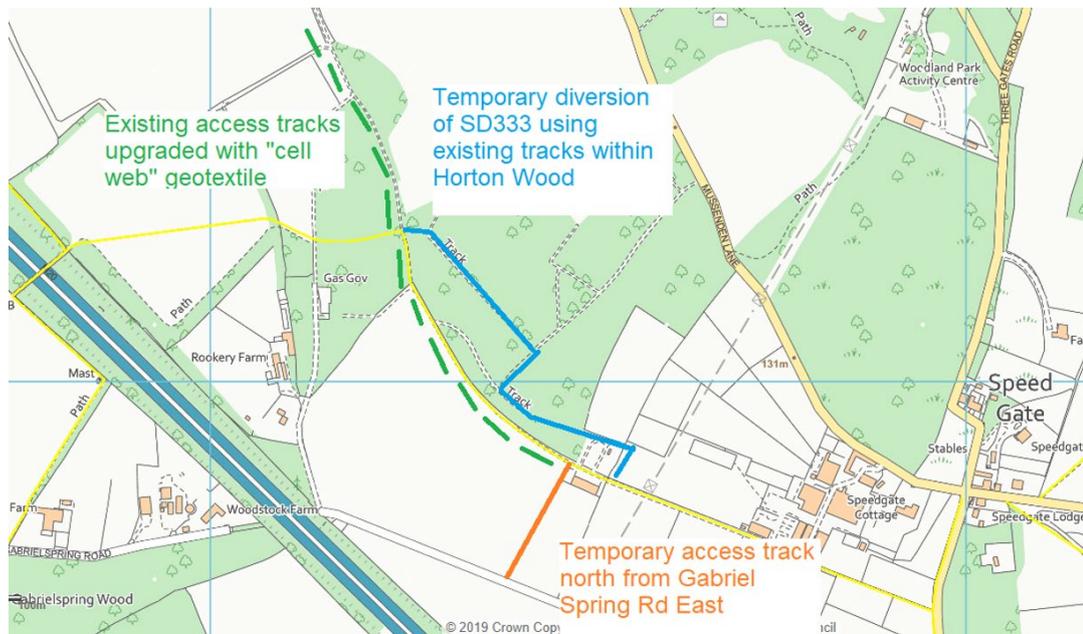
Plate 2.1 – Proposed Temporary Public Footpath Diversion Route

- 2.11. Within the Planning Addendum document, it has acknowledged that during the construction period traffic will be routed along the existing track through the site which correlates with the alignment of Public Footpath SD333.
- 2.12. To resolve this, the applicant is proposing a temporary diversion route for the construction period as detailed below. This will enable the public to continue to utilise tracks and the onwards PROW network safely during this construction period. It is proposed that this alternative route will be clearly signposted for ease of use.

- 2.13. It was agreed with KCC that the alternative routing could be confirmed post application and that, if necessary, the alternative route could be amended to any such similar route depending on the construction phase and activities as long as construction traffic and the general public have separate routes. As such there would be no concern regarding user safety.
- 2.14. It is understood that the temporary closure and realignment will be agreed with Kent County Council under a separate agreement prior to any works commencing on site and can be secured by condition if necessary. As it typical of any PROW diversion, notices will be given on site giving advance warning of the diversion.

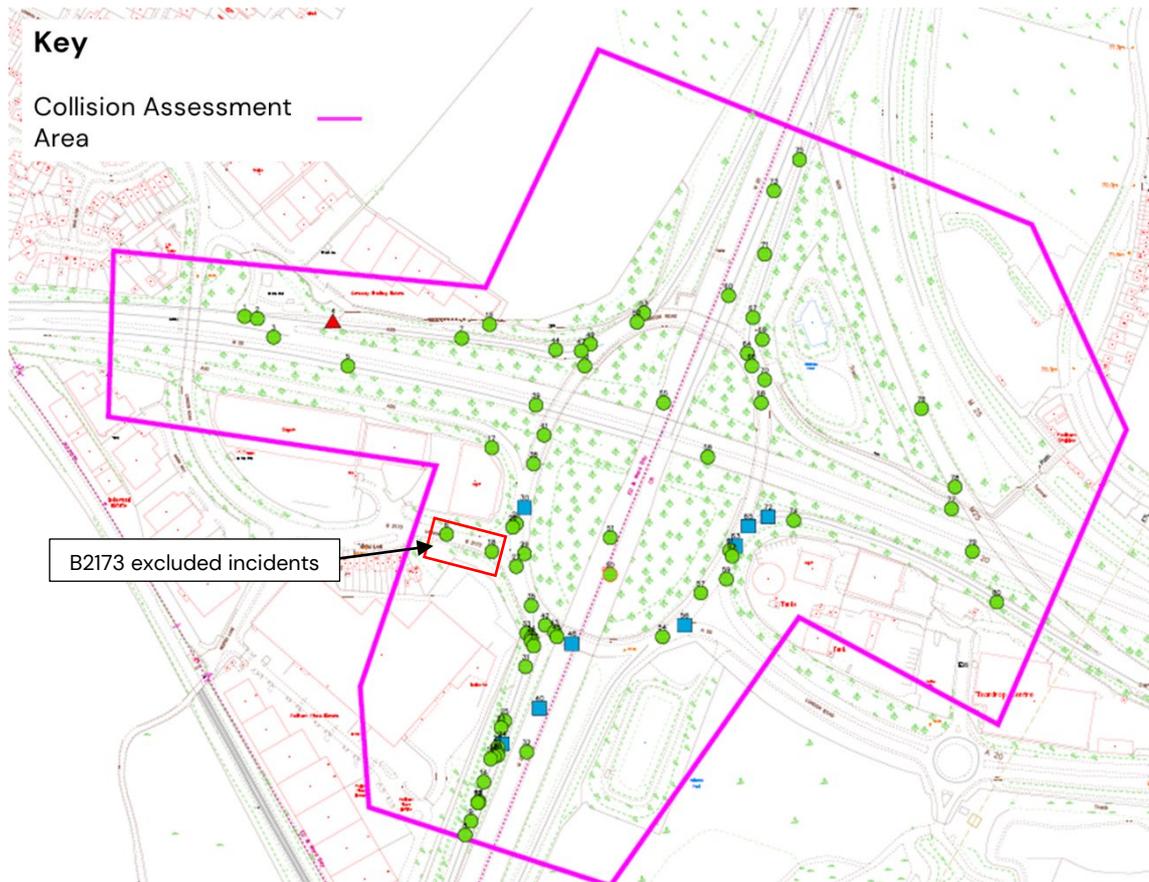
Plate 3.1 – M23 Junction 3 Swanley Interchange – Collision Assessment Area

- 3.10. STATS19 Personal Injury Collision (PIC) data has been obtained from KCC for the eight year period requested (01 January 2015 – 30 September 2023), covering five years pre-pandemic and all available post-pandemic years.
- 3.11. **Plate 3.1** illustrates the collision assessment area and PIC locations with the full data outputs provided in **Appendix C**.

- 3.12. A total of 80 collisions were recorded within the study area and for the entire period.
- 3.13. Two incidents on the B2173 can be discounted from the analysis as this road does not form part of the construction traffic route.
- 3.14. Whilst all incidents are unfortunately regrettable, the majority (69) of incidents were classified as minor, eight were serious and only one was fatal.
- 3.15. Construction vehicles will use the A20 approach onto and from Junction 3 of the M25. Only one collision was recorded at the A20 approach which construction vehicles are proposed to use. The incident whilst classified as serious was the result of a circulating vehicle failing to stop at a red light. As such there is no common causation factor or trend of accidents on this approach which would be exacerbated by the traffic associated with the development.

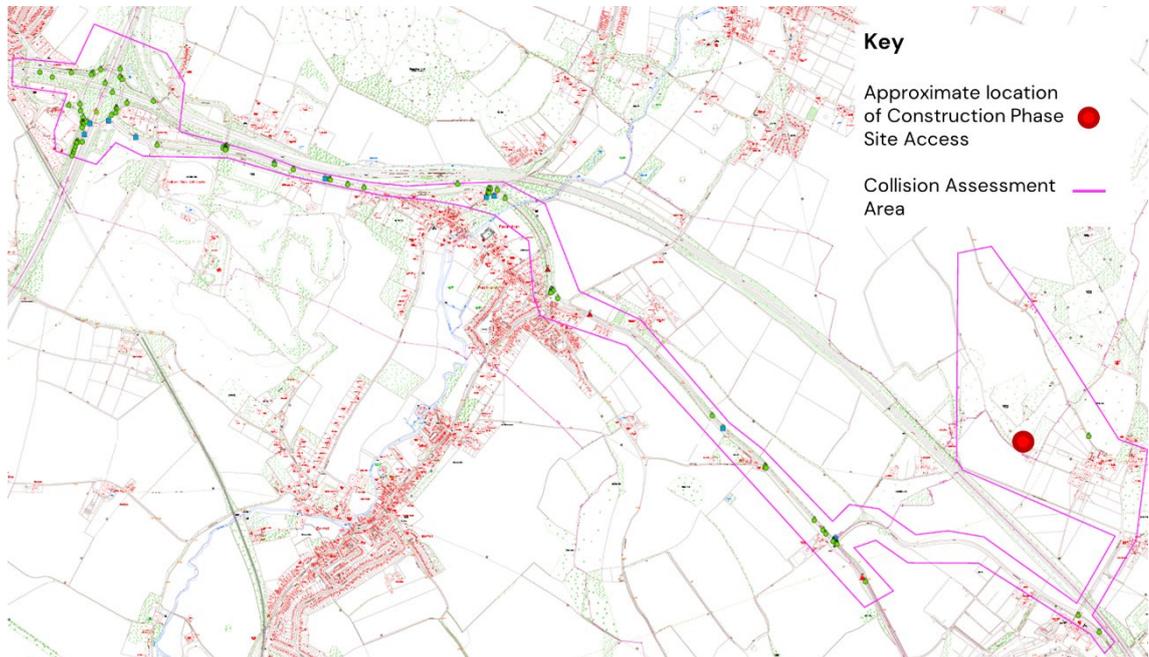
Plate 4.1 – PIC study area

- 4.21. Based on this, the following sections sets out the additionally required PIC data which covers the latest five-year period (01 October 2018 – 30 September 2023). The data provided by KCC is provided in **Appendix F**.
- 4.22. The area of study set out in **Plate 4.1** below covers the construction route from the M25 Junction 3 Swanley Interchange (M25 Junction 3) to the proposed development site, via the A20. The below analysis excludes the M25 Junction 3 Swanley Interchange which is analysed separately above in response to NHs comments where it was concluded there was no highway safety concern associated with the junction. The study area considers the full extent of the construction route beyond which trips will dissipate across the Strategic Road Network.

- 4.23. The PIC data indicates a total of 49 collisions within the study area. Of these collisions there were three fatal collisions all located on the A20, nine serious collisions and 37 slight collisions.
- 4.24. Of these total collisions across the five-year period, 13 collisions involved goods vehicles over 3.5 tonnes (27% of recorded collisions) and only two of these were HGVs (4% of recorded collisions). The construction traffic associated with the site will be a combination of vehicles from cars/vans up to 16.5m articulated HGVs.
- 4.25. Many of the accidents can be attributed to driver behaviours, with there being multiple instances of vehicles failing to slow down in time for stationary traffic, and in some cases this leading to multiple vehicles being affected by this.
- 4.26. The number of collisions per year are summarised in **Table 4.4** below.

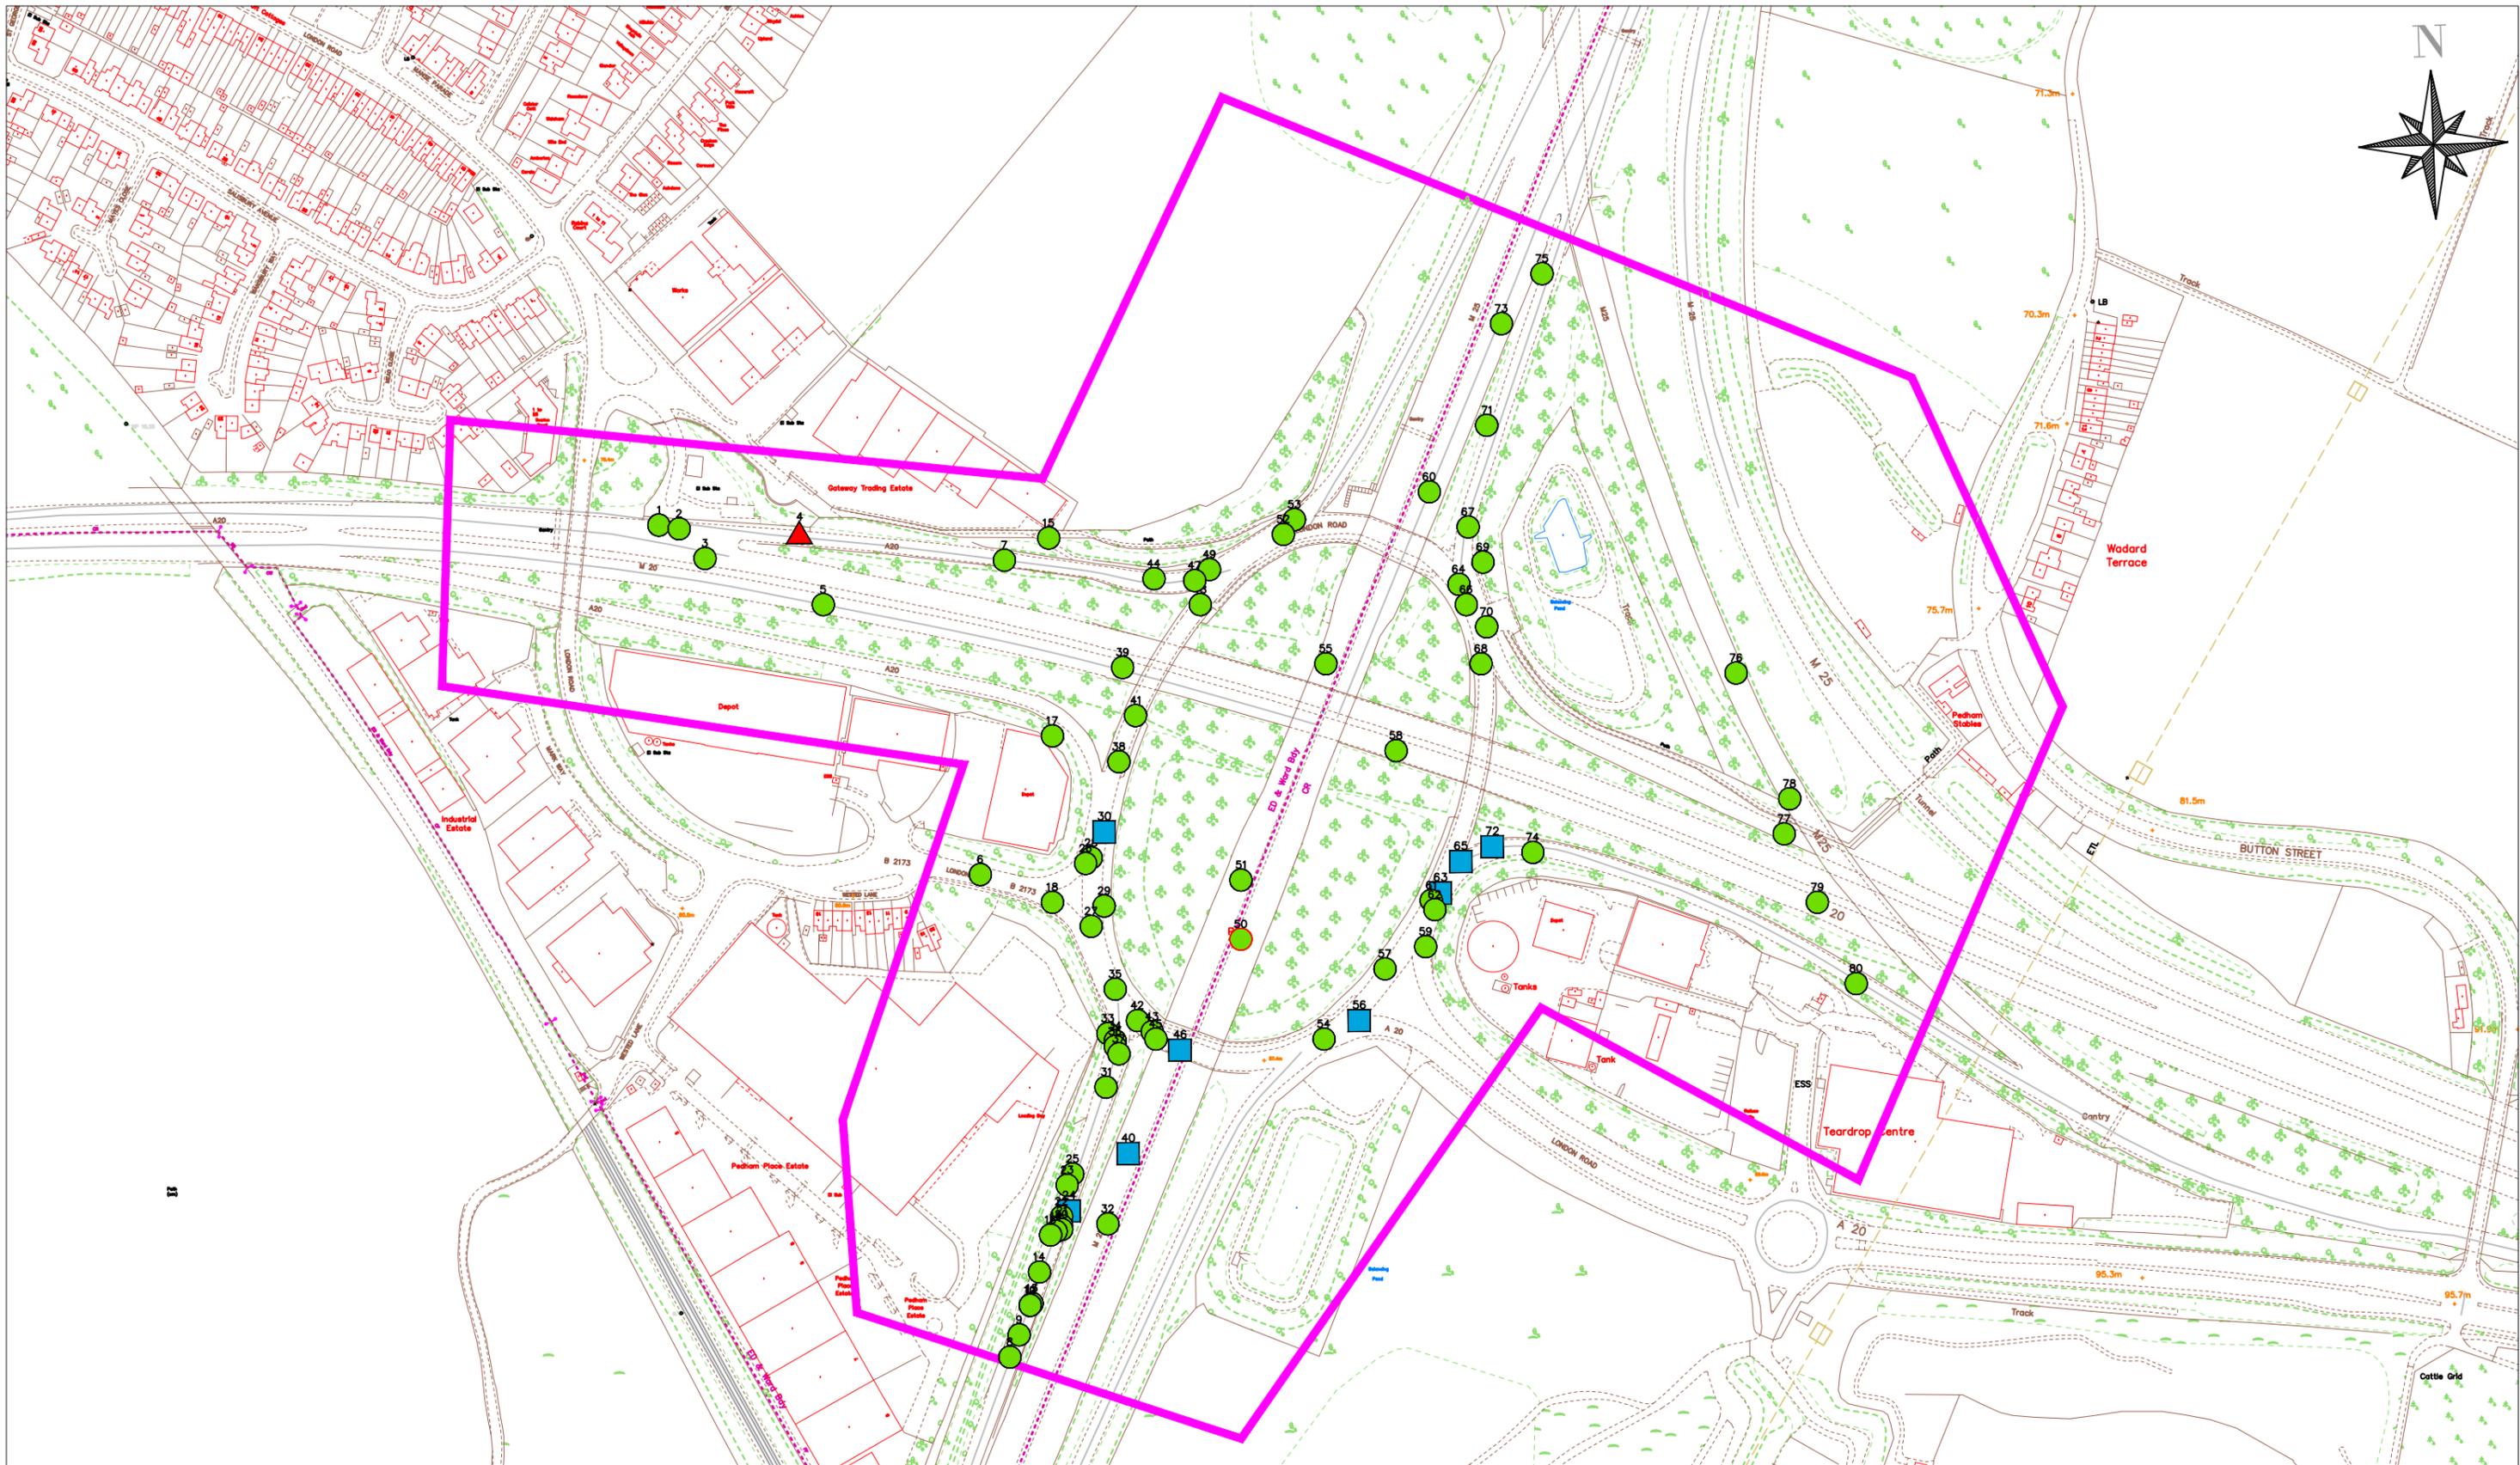
Appendix C – M25 Junction 3 PIC Data

Location: M25, J3 Farningham
 Personal injury crash data 01/01/2015 up to 30/09/2023
 KCC Ref number: EXT/023/24

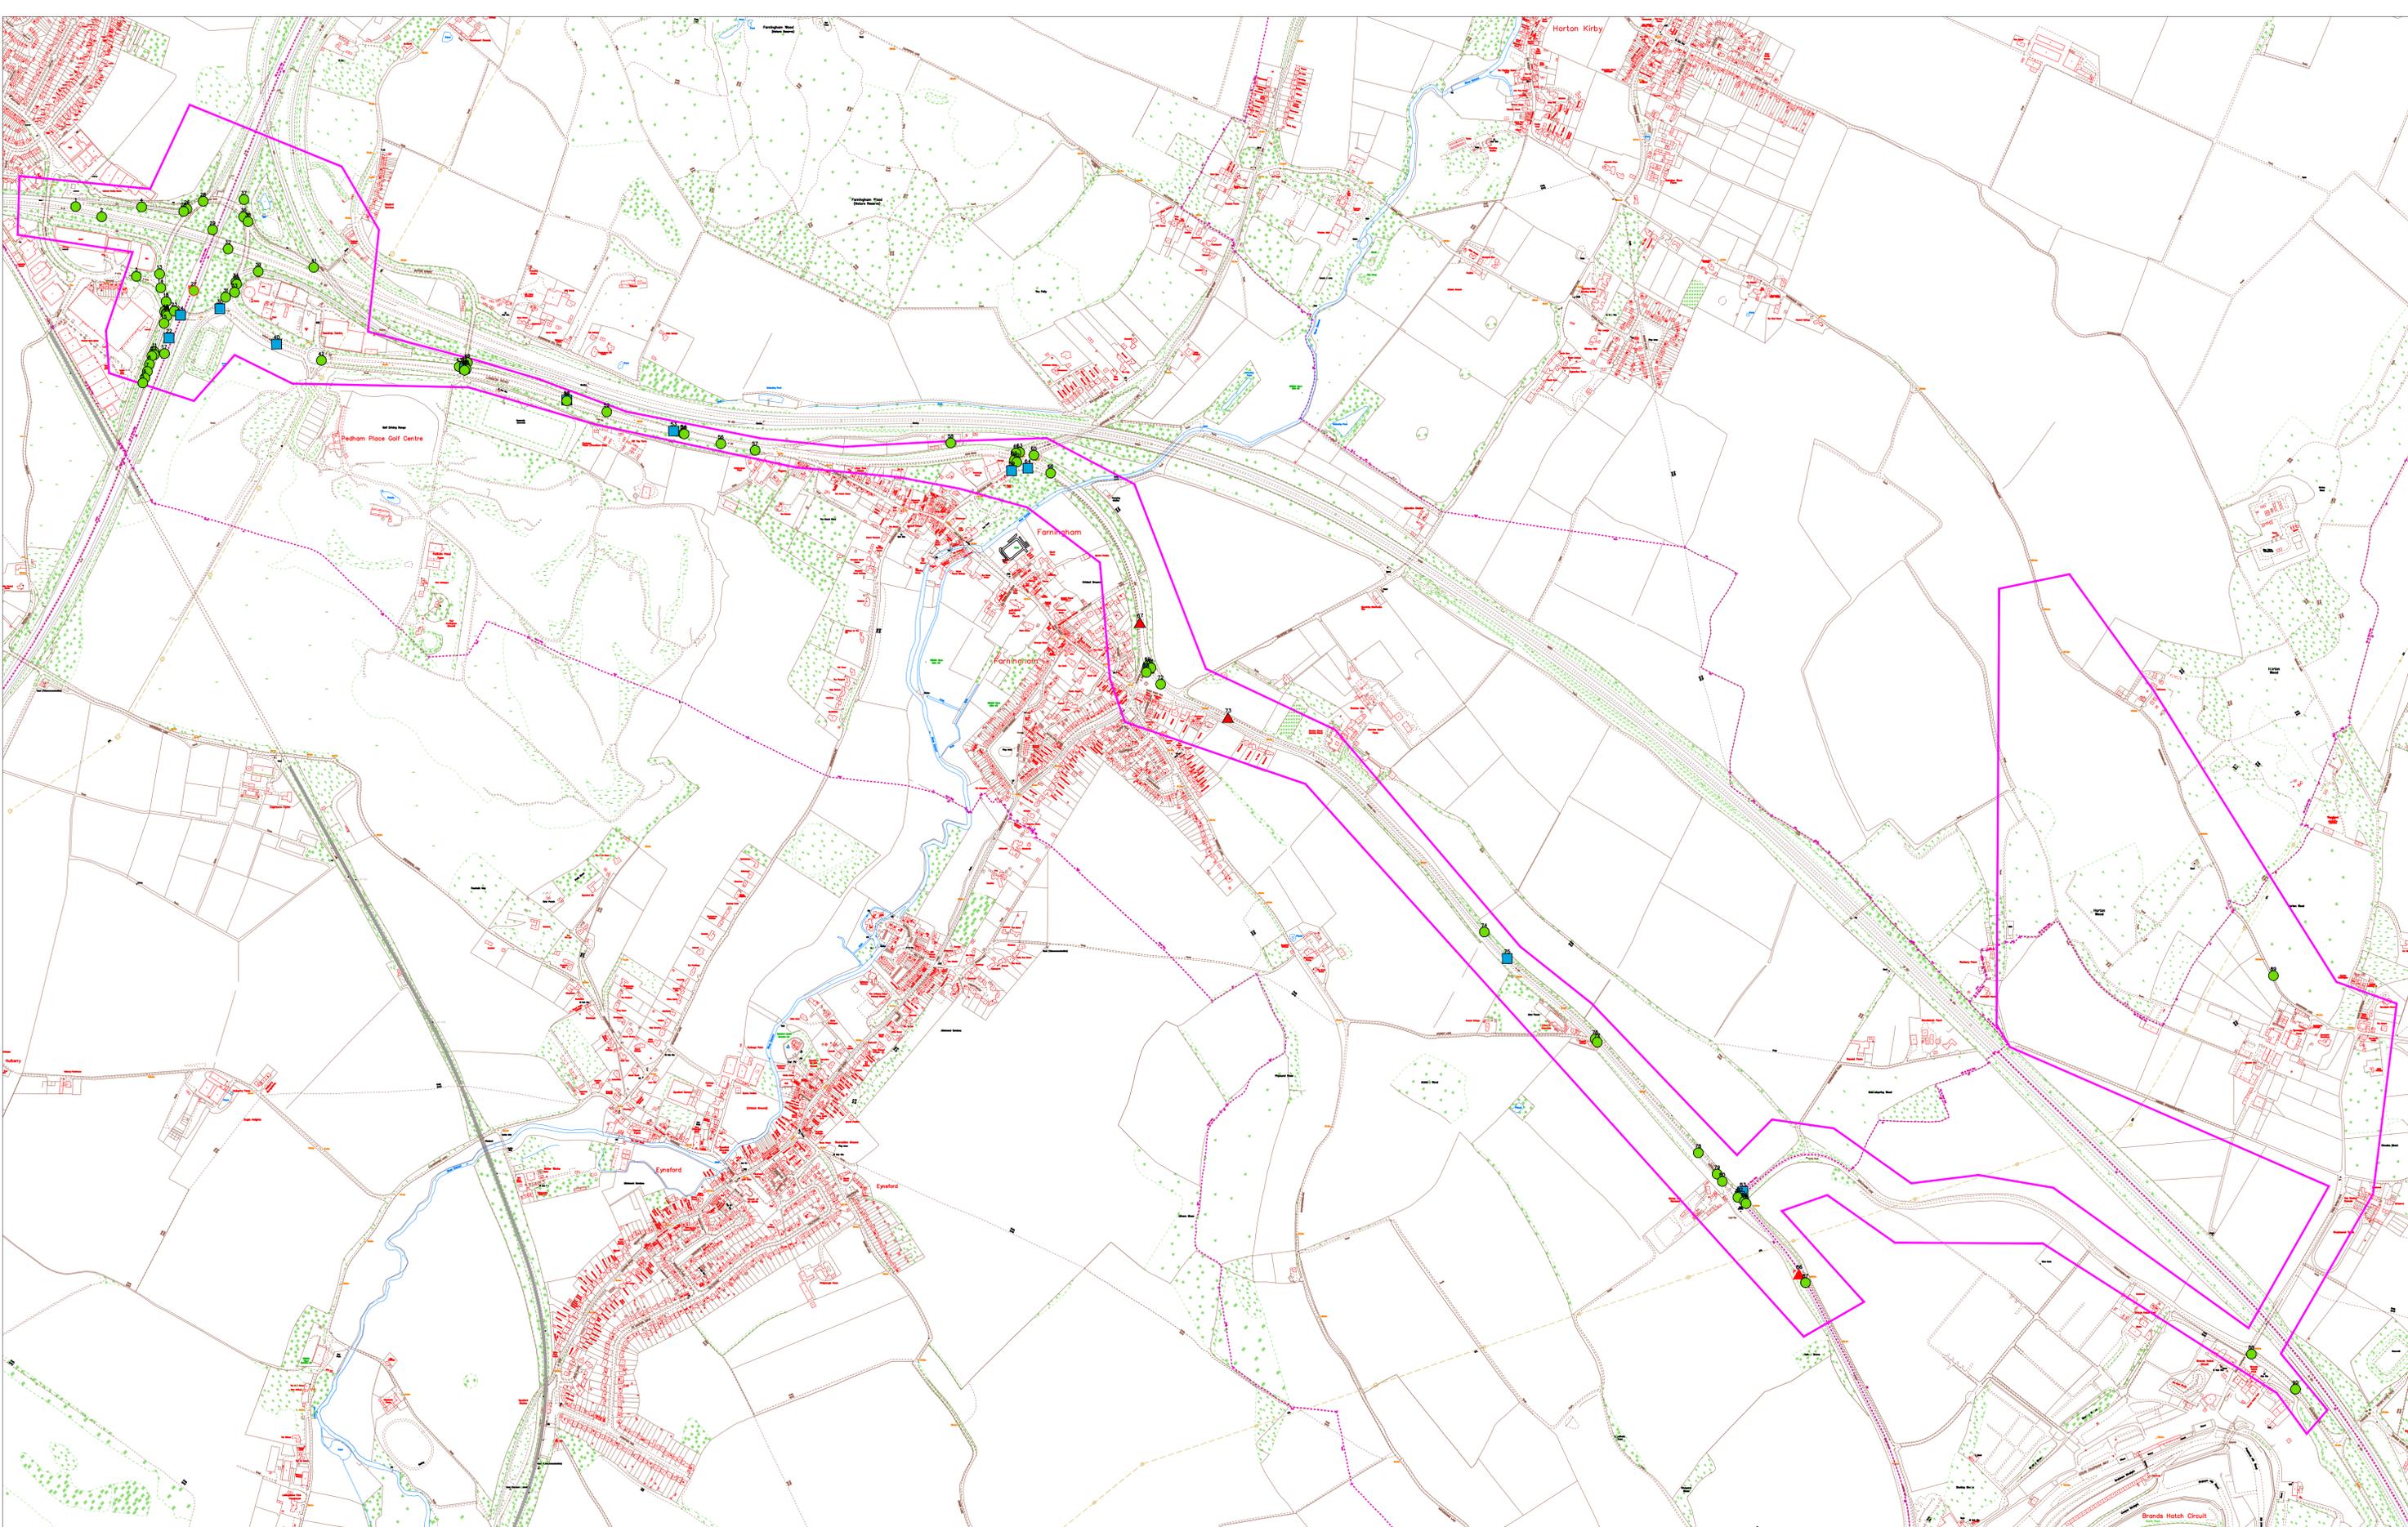
Appendix F – Local Highway Network PIC Data

Location: A20 and M25 J3, Farningham
 5 years personal injury crash data up to 30/09/2023
 KCC Ref number: EXT/024/24

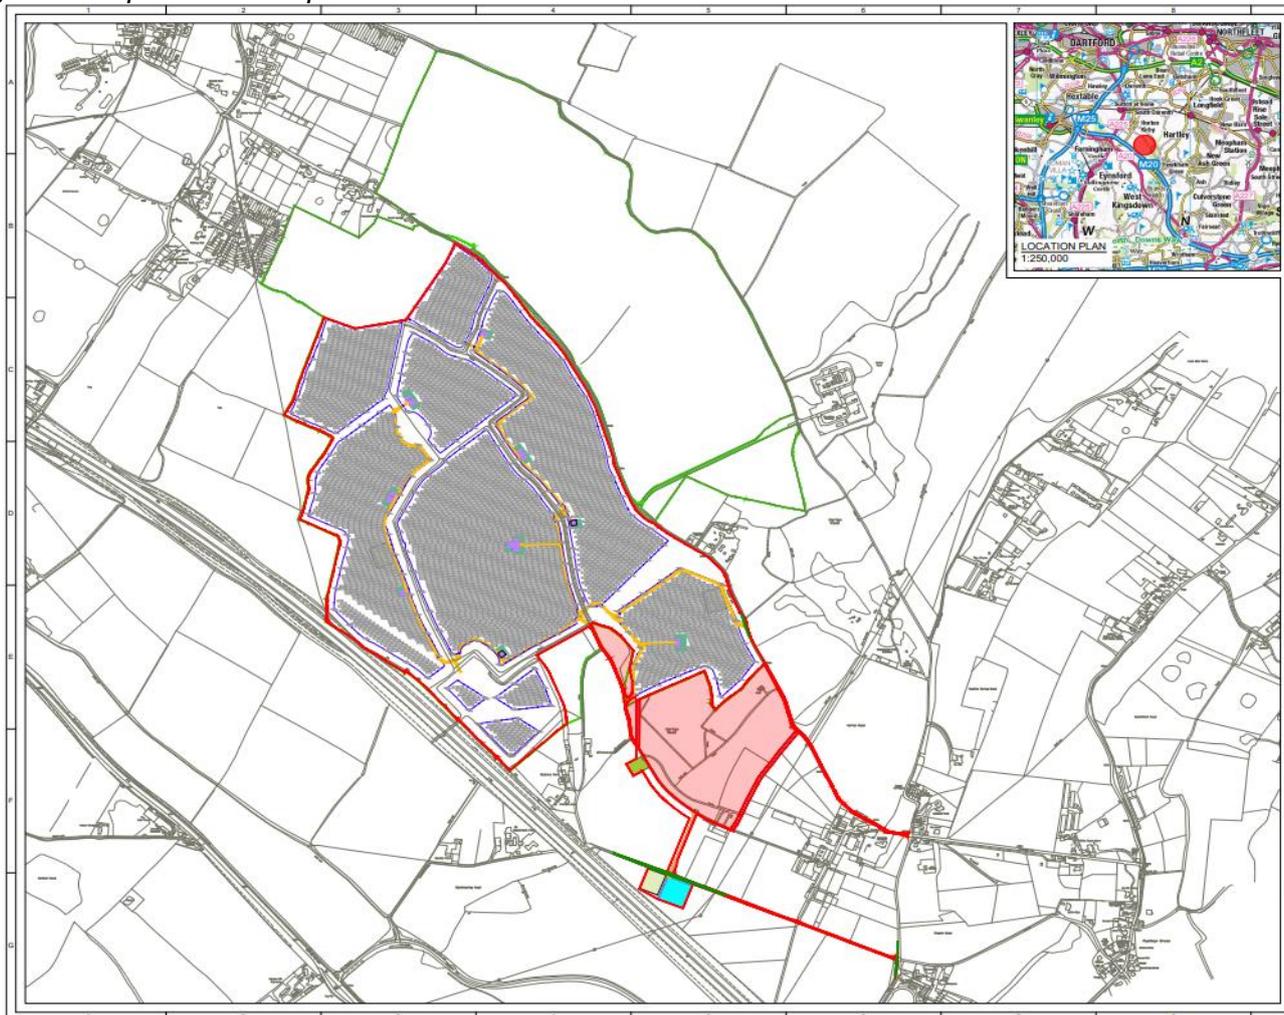
Figure 1 Proposed Development Plan

The Proposed Development plan is shown below in Figure 1 and details the proposed solar panel layout.

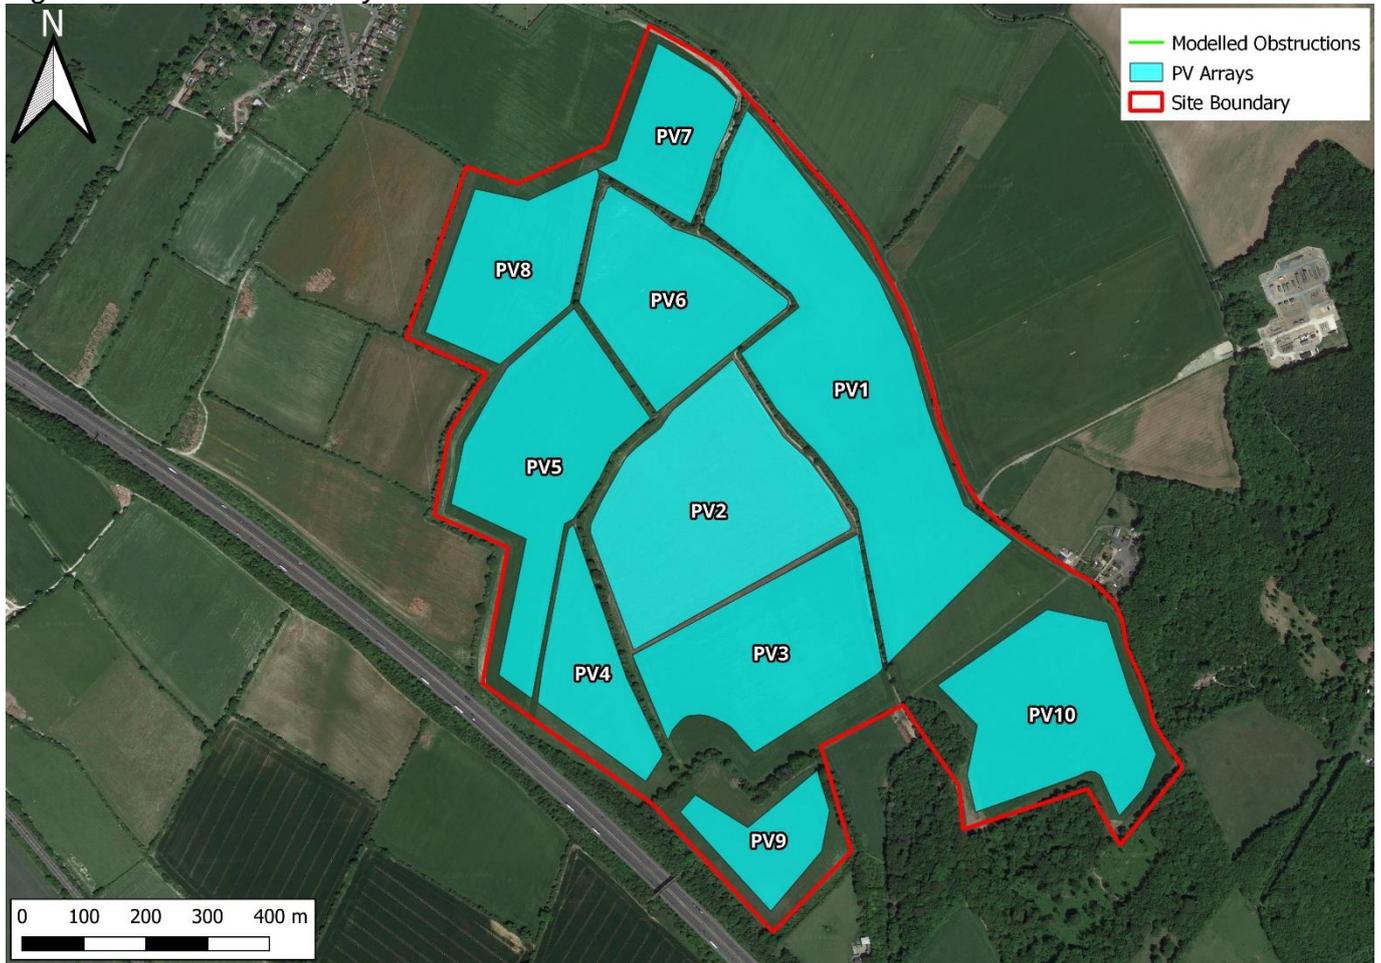
Figure 2 Assessed PV Arrays

For assessment purposes, the proposed array layout was simplified as shown in Figure 2 below. This is consistent with the original assessment. The assessed PV module orientations and inclinations, as well as the modelled panel height, are summarised in the below table. A range of tilts are under consideration between 10° and 20° for the ground-mounted arrays. As such, two different potential design angles (10° and 20°) were modelled to provide a robust glare assessment.

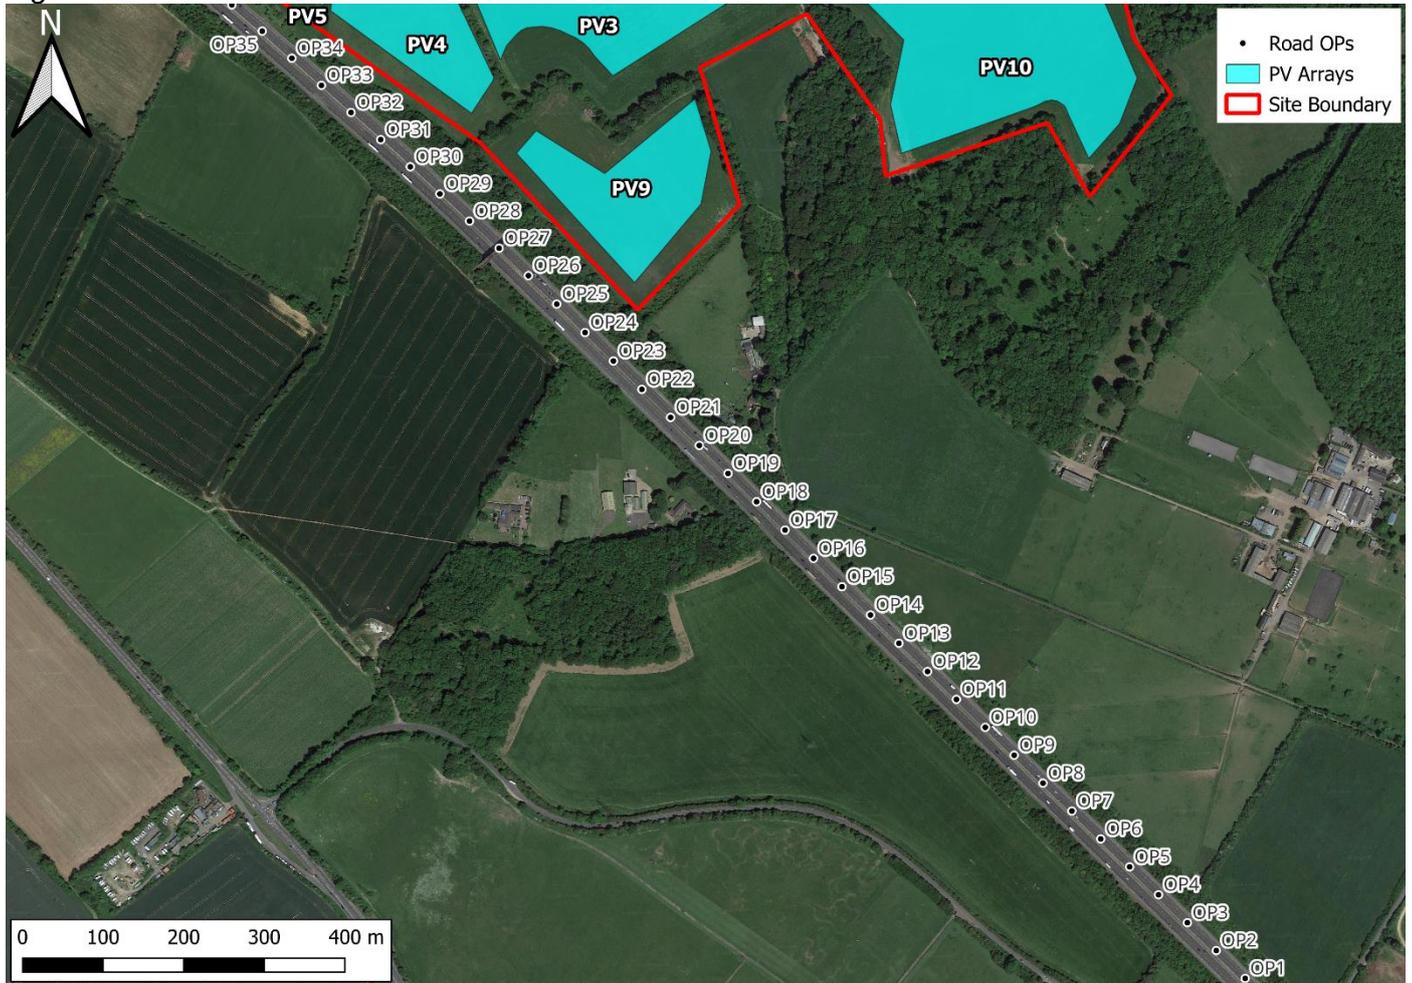
Figure 3 Modelled Road OPs 1-35

As per the instruction of National Highways, the M20 road to the south of the Proposed Development has been modelled with observation points as a worst-case approach. The observation points were modelled at 50m intervals for the full length of the road, as shown in Figure 3 and Figure 4.

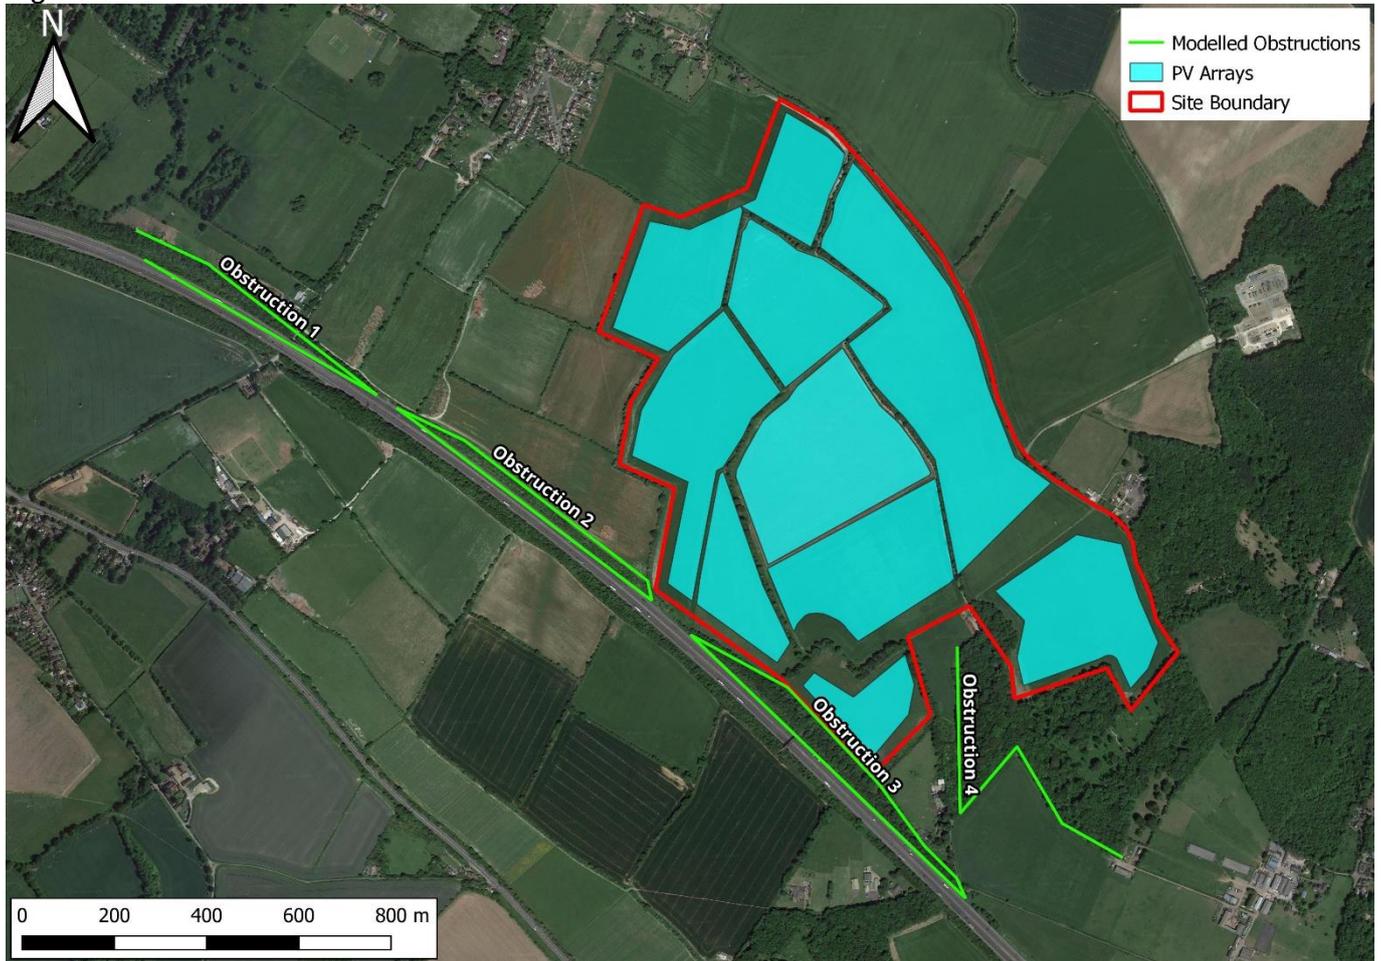
Figure 5 Modelled Obstructions

As per the original report, vegetation was modelled within the assessment as an obstruction of line of sight between light-sensitive receptors and the PV arrays. The heights of the obstructions were approximated using Google Street View and can be found below. The location of the obstructions can be seen below in Figure 5.

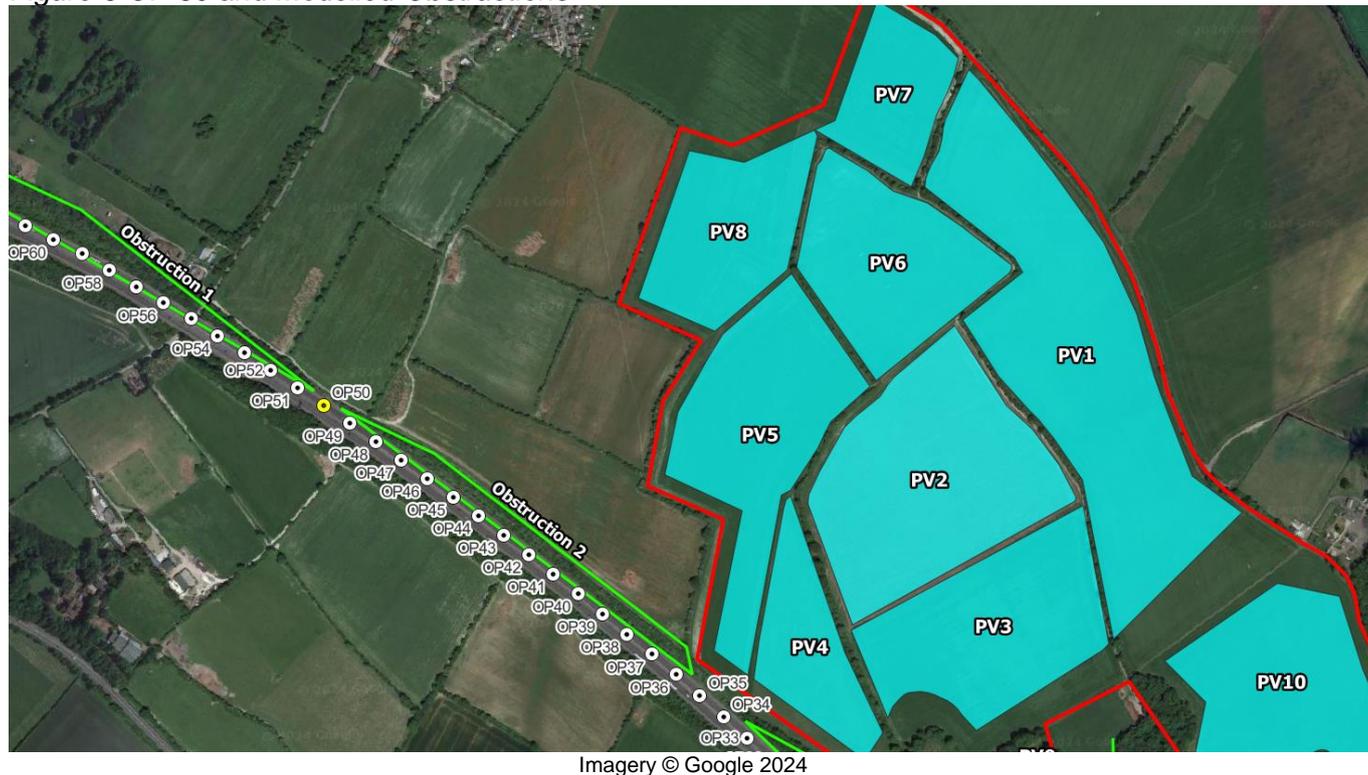
Figure 6 OP 50 and Modelled Obstructions

Therefore, as glare is not geometrically possible, there would be “no impact” toward road users at OP 50.

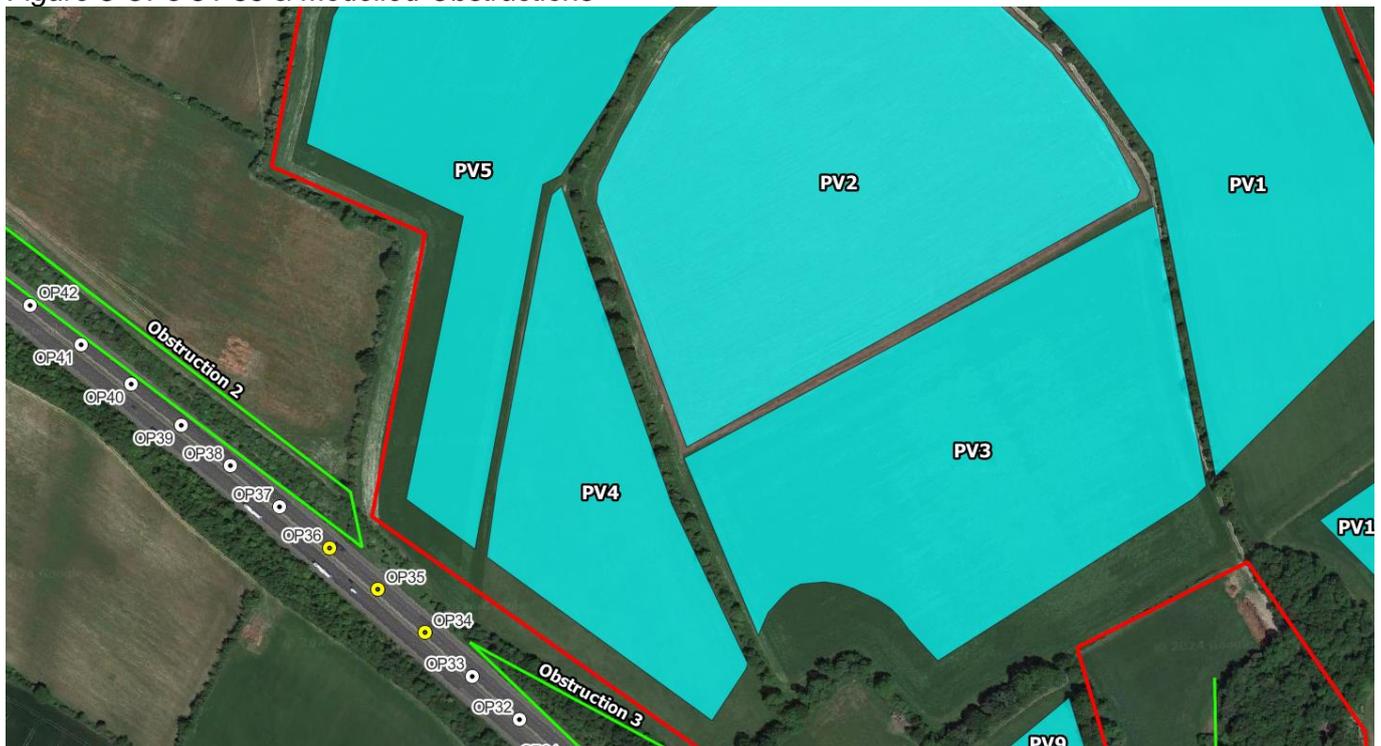
Figure 8 OPs 34-36 & Modelled Obstructions

OPs 34-36 are located between Obstructions 2 and 3. There is no vegetation bounding the M20 that has been modelled. This is shown in Figure 8.

The model therefore predicts glare from PV1 – PV5 toward OP35, glare from PV1-PV4 toward OP34 and glare from PV3-PV5 toward OP36.
