Traffic Note Addendum

Land at Chimmens Solar Farm, Mussenden Lane.

Date: March 2024 | Pegasus Ref: P22-1221_R002 RevA_TR_AJ_JB

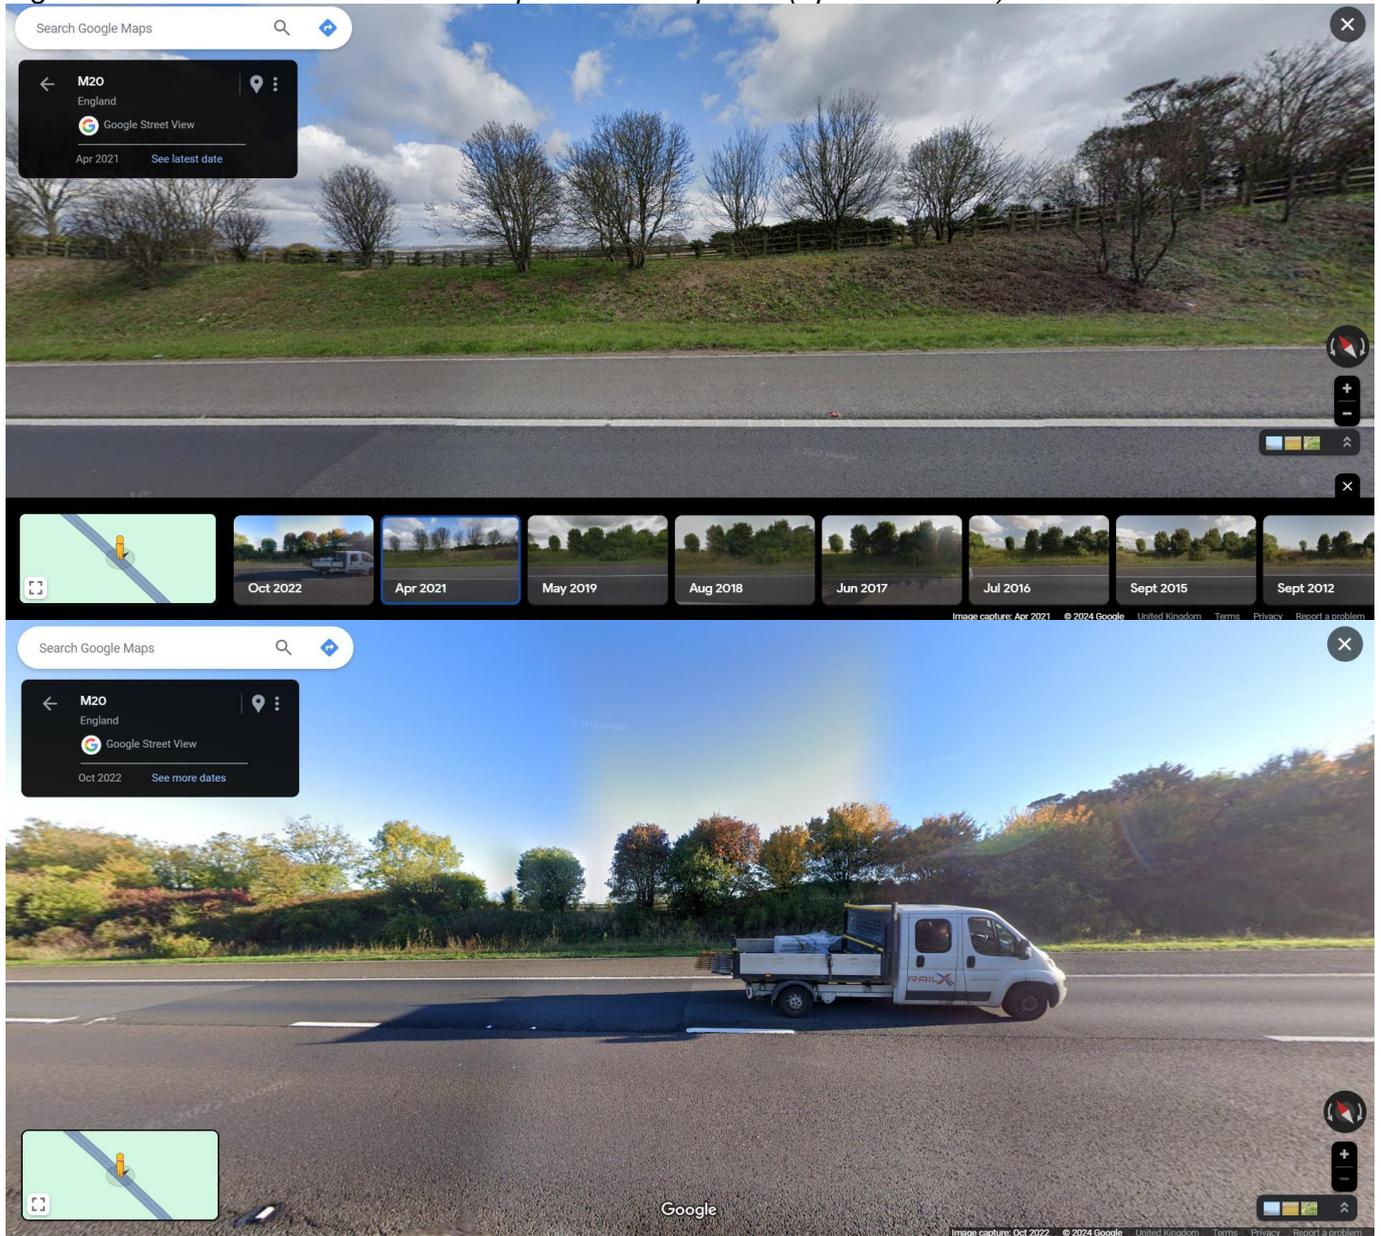
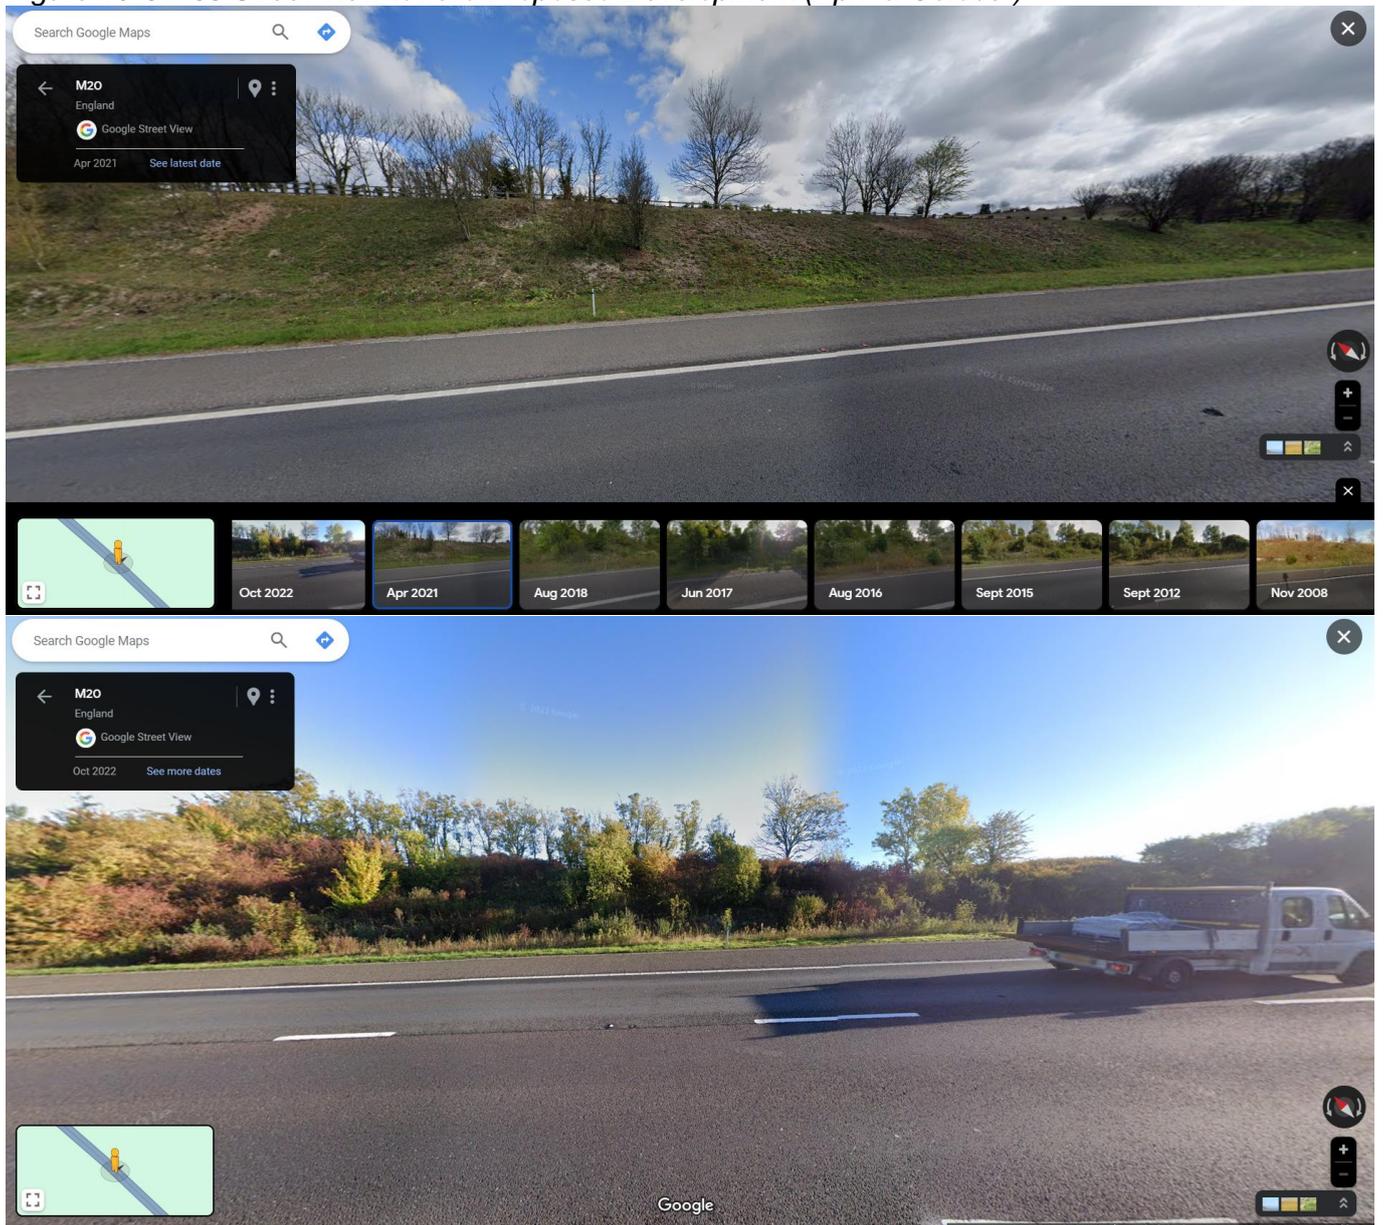
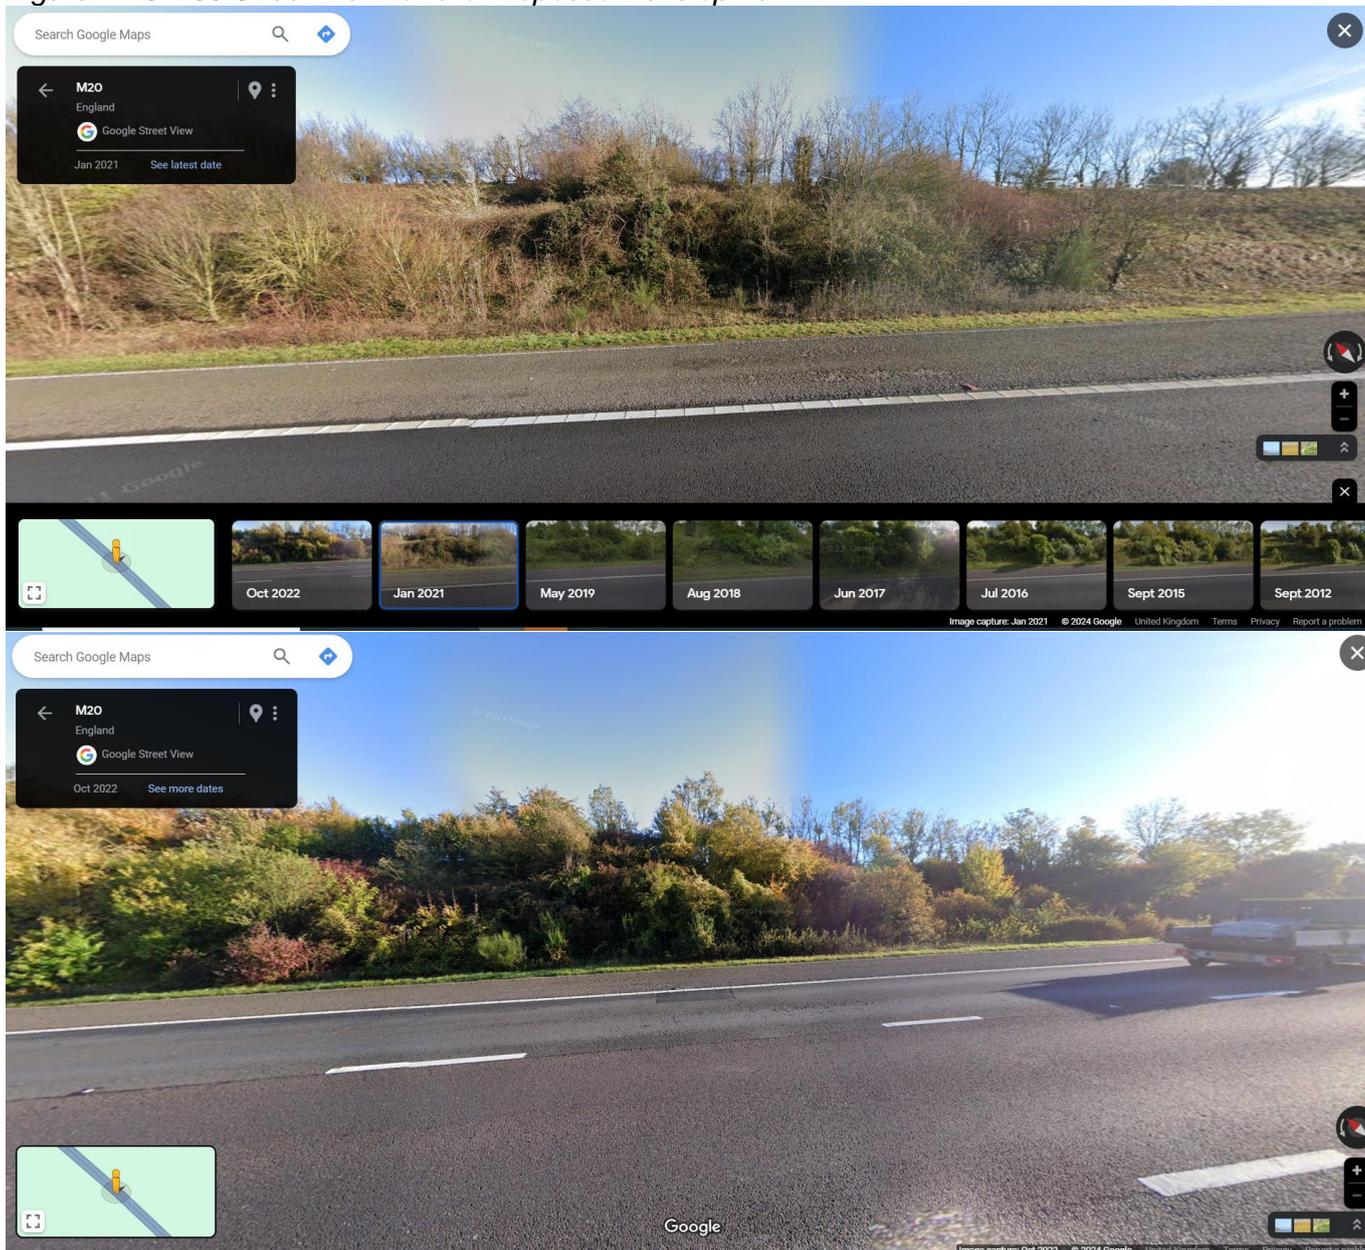
A further review of Google Street View image is presented in Figures 9-11. These images show that the potential view of the arrays PV1-3 and PV5 is blocked by the vegetation and embankment aligning the M20 and also by the field containing PV4. Therefore, as glare is not geometrically possible, there would be “no impact” toward road users at OPs 34-36 from PV1-3 and PV5.

With regard to PV4, the review of Google Street View images indicates that the embankment provides good screening of line of sight for the majority of the OP 34-36 section of the M20. This is supplemented by vegetation which provides additional screening from May to October.

Whilst additional mitigation is not considered to be strictly necessary, installation of opaque fencing or all-year-round vegetation along this specific section of the road could further mitigate potential glare from array PV4, resulting in an ‘insignificant’ residual impact.
