3. Archaeology

3.1. This section seeks to address comments made by the County Archaeologist on 2 February 2024. A trial trench evaluation was undertaken within the site in November 2023 to January 2024. The Archaeology Officer was consulted on the scope of the trial trench evaluation, comprising the excavation of 124 no. 30m x 2m trenches, targeting the anomalies of archaeological origin, geological anomalies, undetermined anomalies, as well as blank areas across the site. The Archaeology Officer attended a site meeting in order to view some of the trenches. It is noted that her recommendation was as follows:

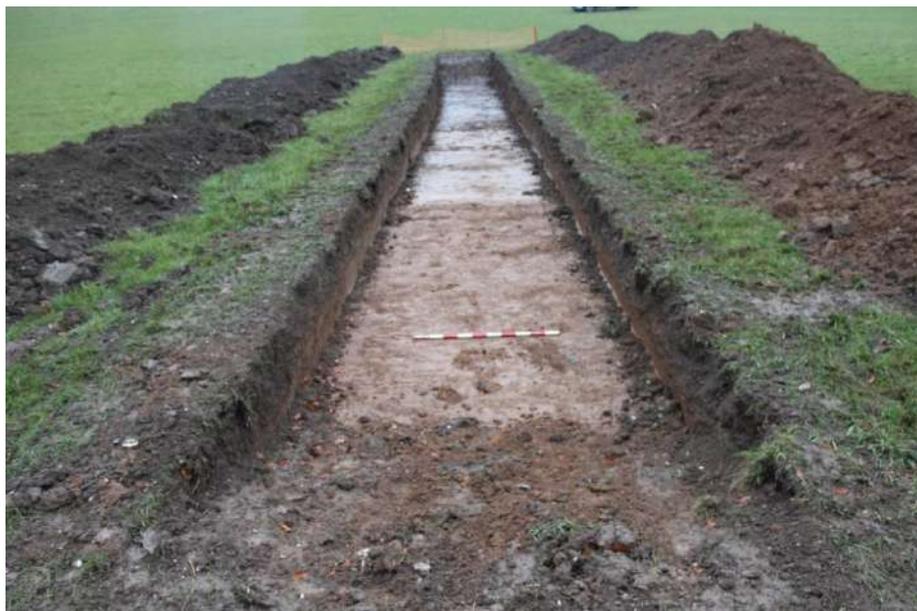
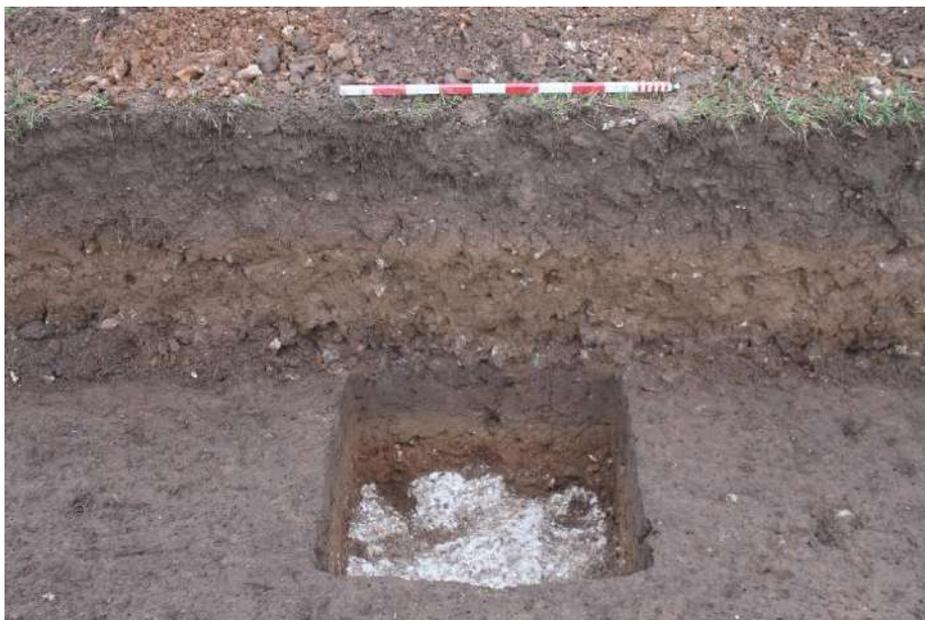
Trench 14 Plate 1

Trench 14 contained natural brickearth at the SW end. At the NE end natural chalk deposits were overlain by three layers of paleosoil, in which IA/Early Roman pottery was found. The trench was sealed by modern subsoil and topsoil.

- 9.4 The only archaeology dating to the prehistoric period was encountered in Trench 14 in the form of buried Paleosoils. The earliest paleosoil deposit (311), 62.4m OD, was a compact orange clay which was overlain by (310), 62.55m OD, a firm yellowish brown silty clay and likely a buried subsoil. Charcoal was present in this deposit as well as very degraded pottery and worked flint. This was overlain by (309), 62.75m OD, which was a firm dark brown clayey silt. The frequent charcoal and evidence of burning in this layer suggests it was a buried topsoil. The layers likely date to Bronze Age/Early Iron Age (tbc).

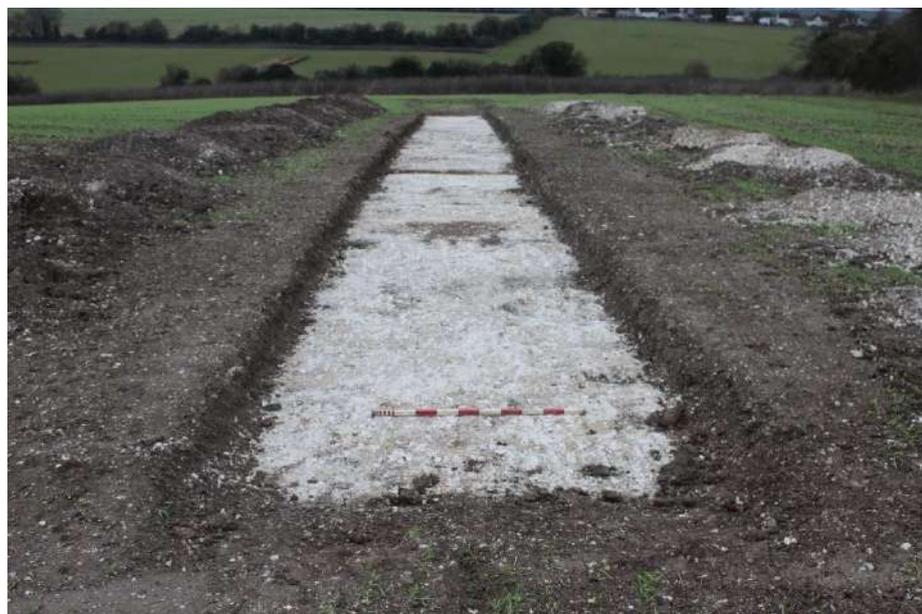
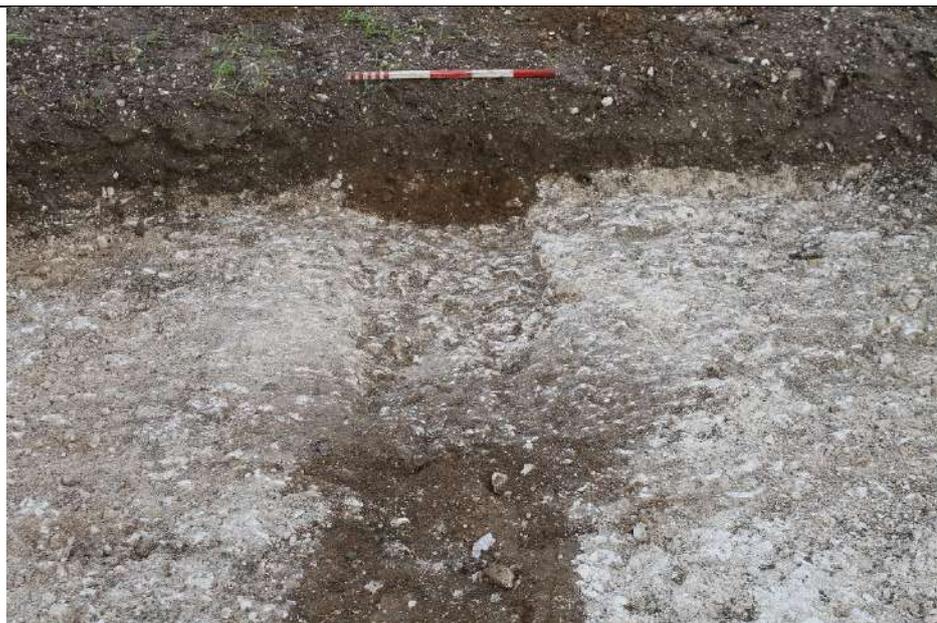
Trench 17 Plate 1

Tr 17
 Plate 1:
 Looking southeast
 1m scale
 Plate 2:
 N-S ditch [304]
 Looking north
 Section 130
 1m scale

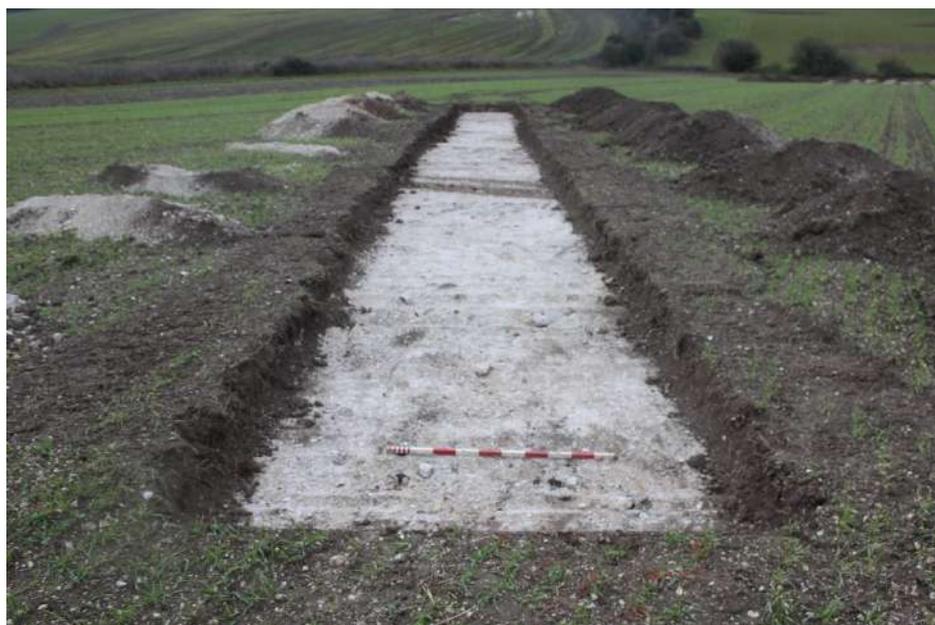
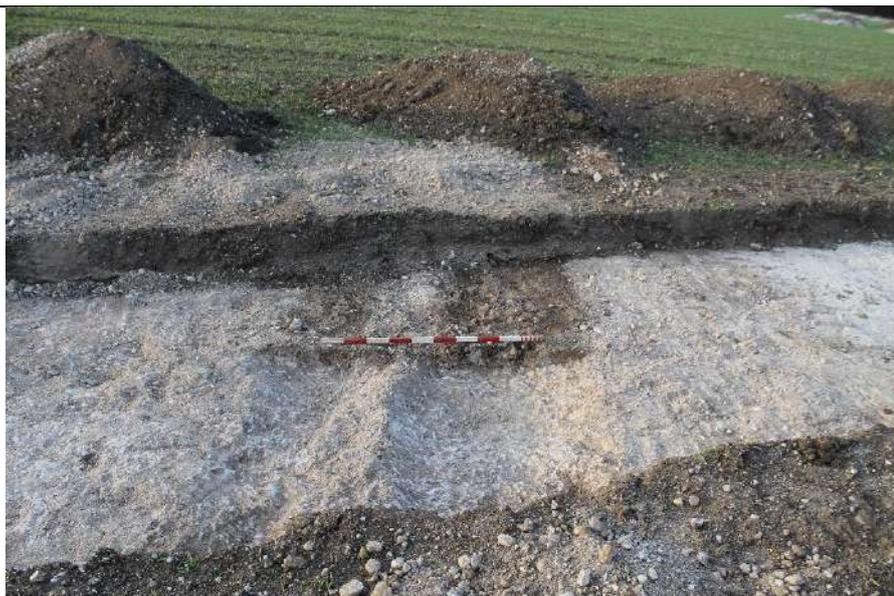
Trench 24 Plate 1

Tr 24
 Plate 1:
 Looking northeast
 1m scale
 Plate 2:
 NW-SE ditches [297]
 and [299]
 Looking northwest
 Section 125
 1m scale

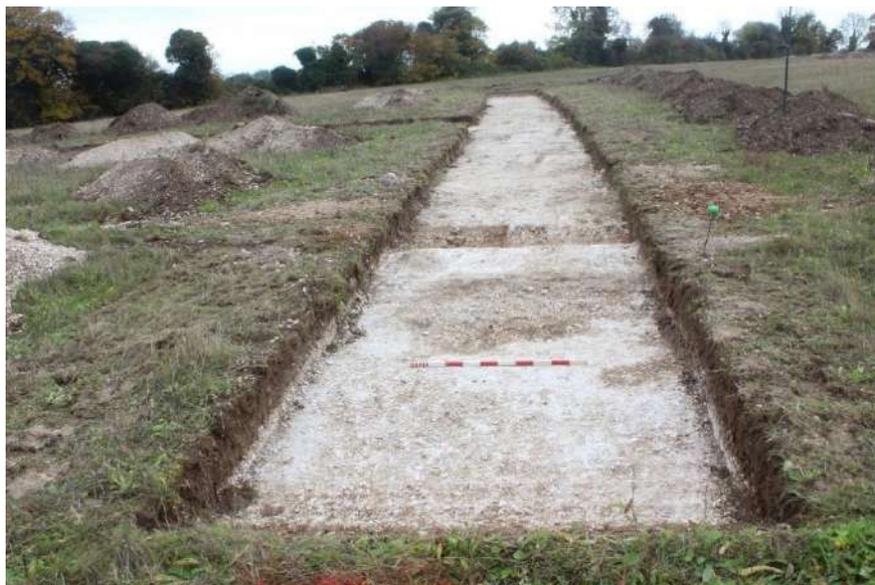
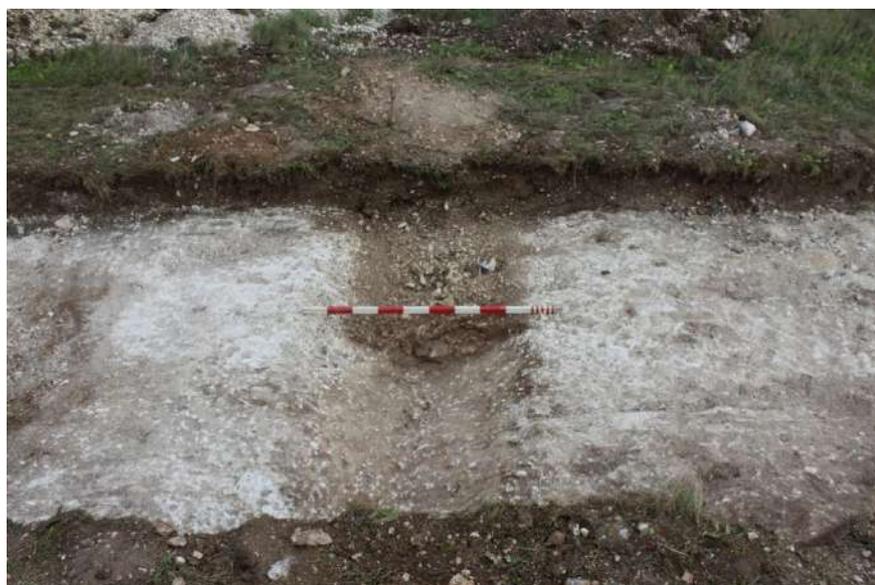
Trench 41 Plate 1

Tr 41
Plate 1:
Looking southeast
1m scale
Plate 2:
NE-SW ditch [136]
Looking southeast
Section 51
1m scale

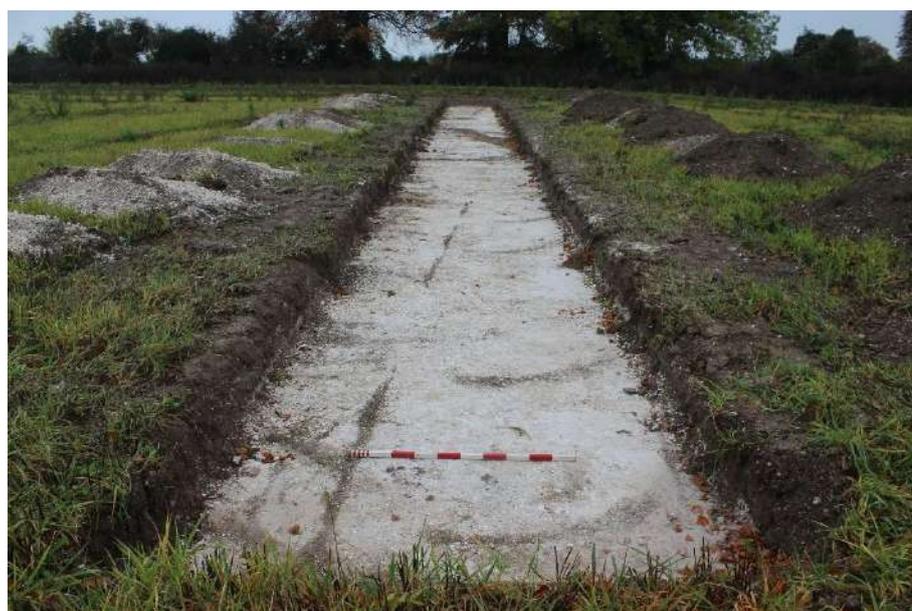
Trench 58 contained a natural chalk deposit that was cut by ditch [128]/[132] (1m long, 0.42m wide and 0.22m deep), which was truncated by pit [126] (1m long, 0.45m wide and 0.24m deep) which were visible on the geophys survey. The trench was sealed by modern topsoil.

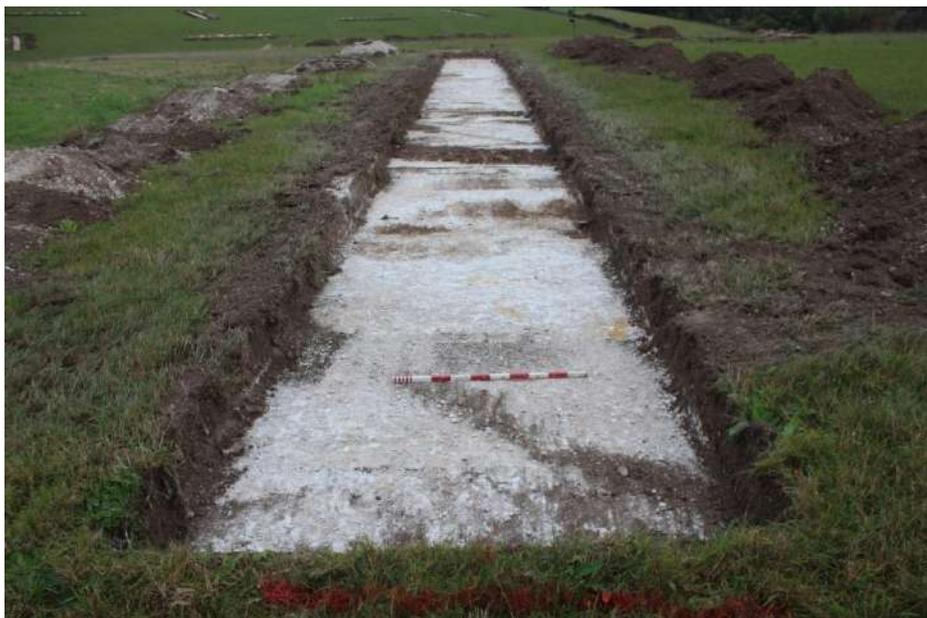
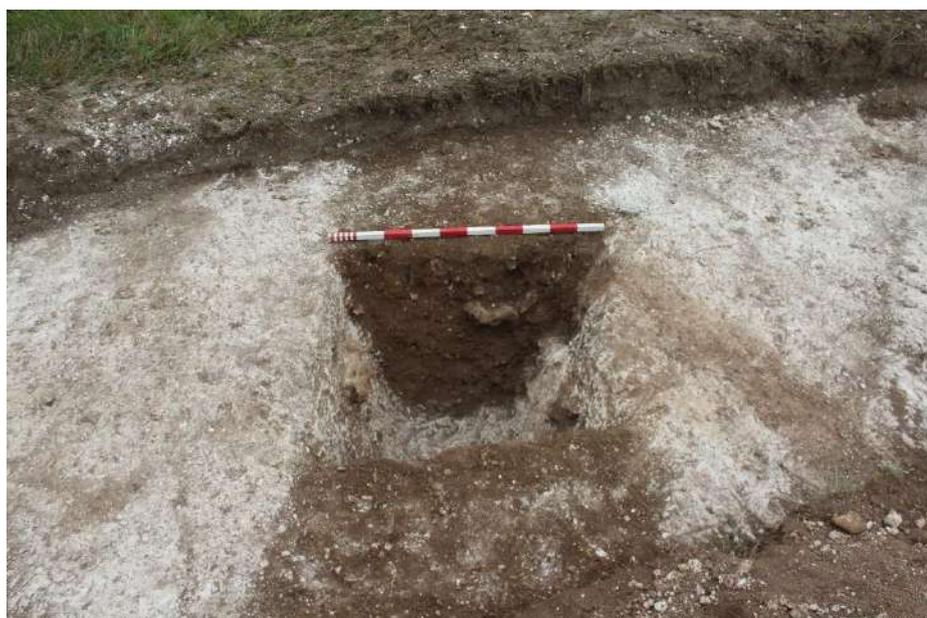
Trench 66 Plate 1

Trench 66 contained a natural chalk deposit that was cut by ditches [113] (2m long, 1.04m wide and 0.78m deep), [107] (0.69m long, 0.55m wide and 0.34m deep), [109] (0.3m long, 0.43m wide and 0.07m deep) and pit [105] (0.73m long, 0.63m wide and 0.19m deep). These features were not visible on the geophys survey. A large finds assemblage was found in ditch [113] which was dated to the LIA/Early Roman period. The trench was sealed by modern topsoil.

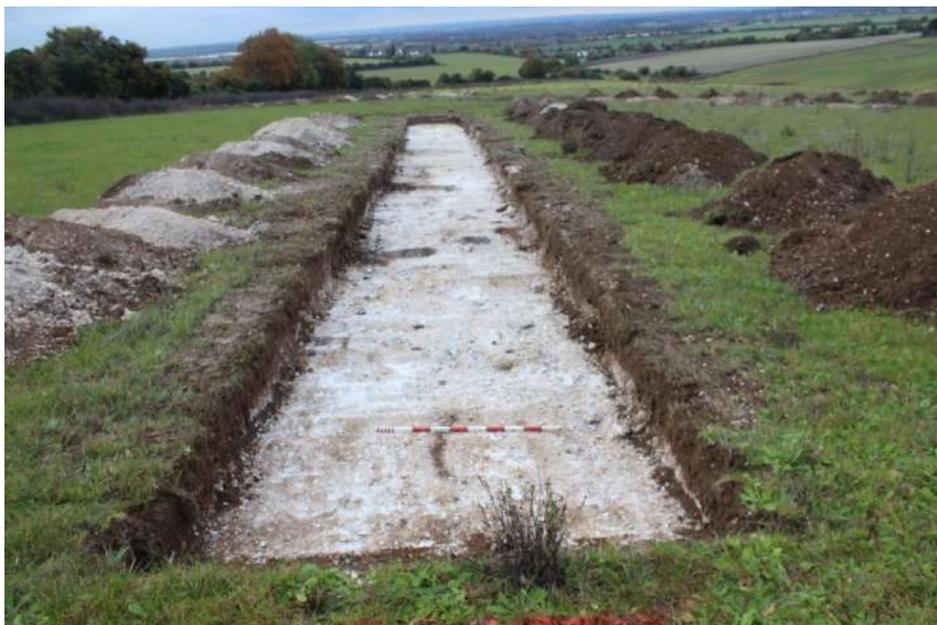
Trench 73 contained a natural chalk deposit that was cut by pits [140], [165], [156], [154], [157], [142], [146], [144]. They ranged in size from 0.27-1.43m long, 0.26-0.60m wide and 0.25-0.84m deep and were visible on the geophysical survey. The pottery assemblage from these pits was dated from MIA to Early Roman. Pit [140] contained three iron objects which were likely Roman. The trench was sealed by modern topsoil.

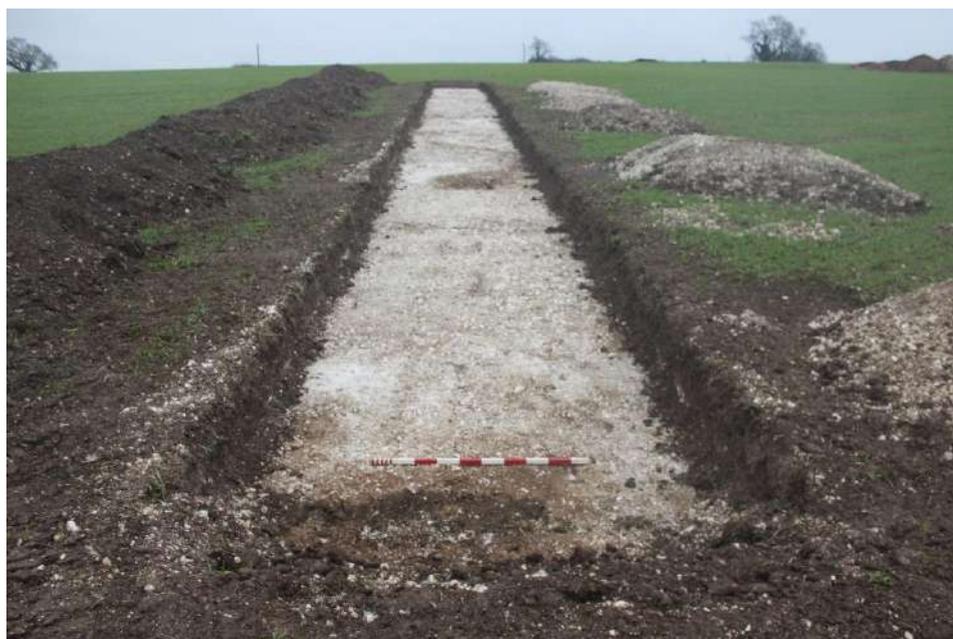
Trench 93 contained a natural chalk deposit that was cut by ditch terminus [409], measuring 1.45m long, 1.11m wide and 0.2m deep. The feature was not present on the geophysical survey. The trench was sealed by modern subsoil and topsoil.

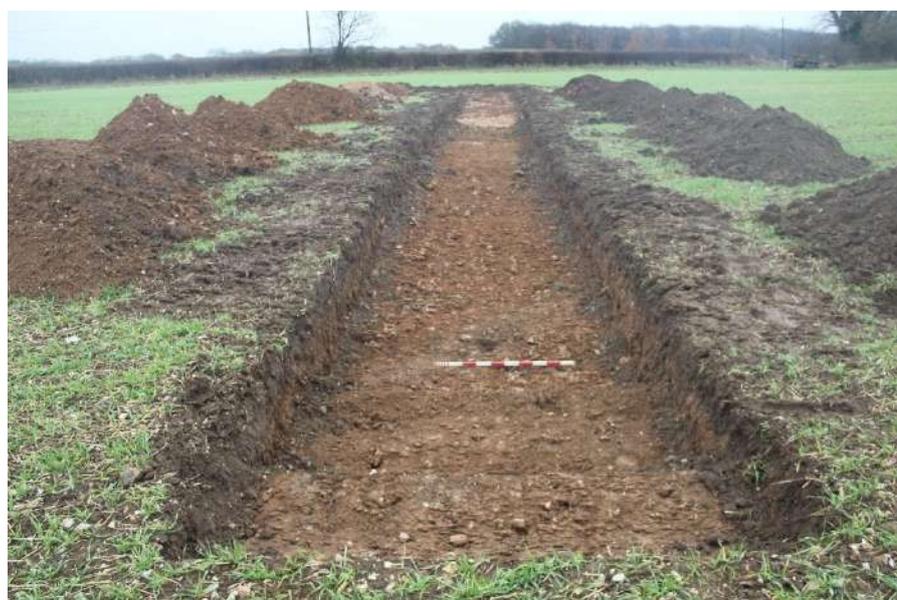
Trench 95 contained a natural chalk deposit that was truncated by ditch [405], measuring 3m long, 0.54m wide and 0.2m deep. Some IA pottery was recovered. The trench was sealed by modern subsoil and topsoil.

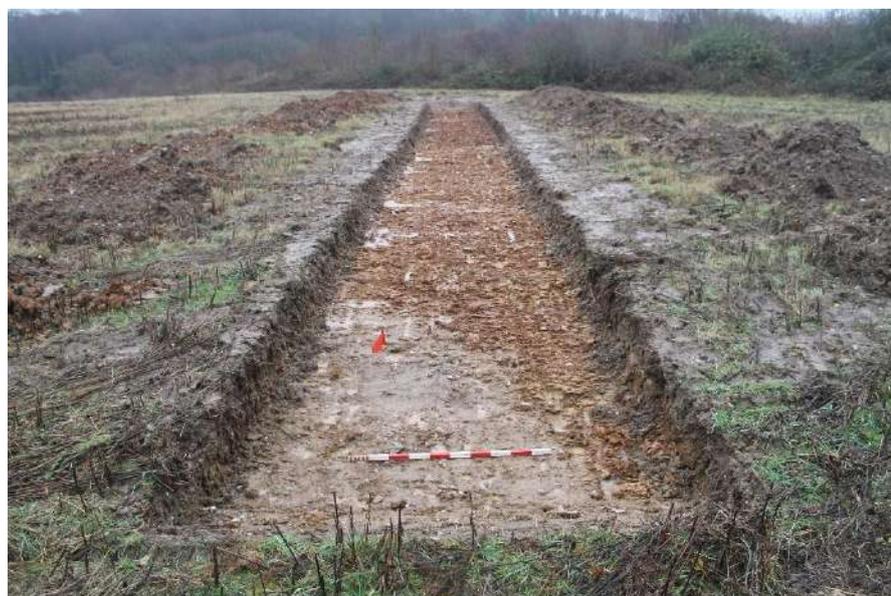
Tr 104
Looking east
1m scale

Trench 104 contained natural brickearth that was truncated by ditch [434], measuring 1.15m long, 0.75m wide and 0.65m deep. The trench was sealed by modern topsoil.

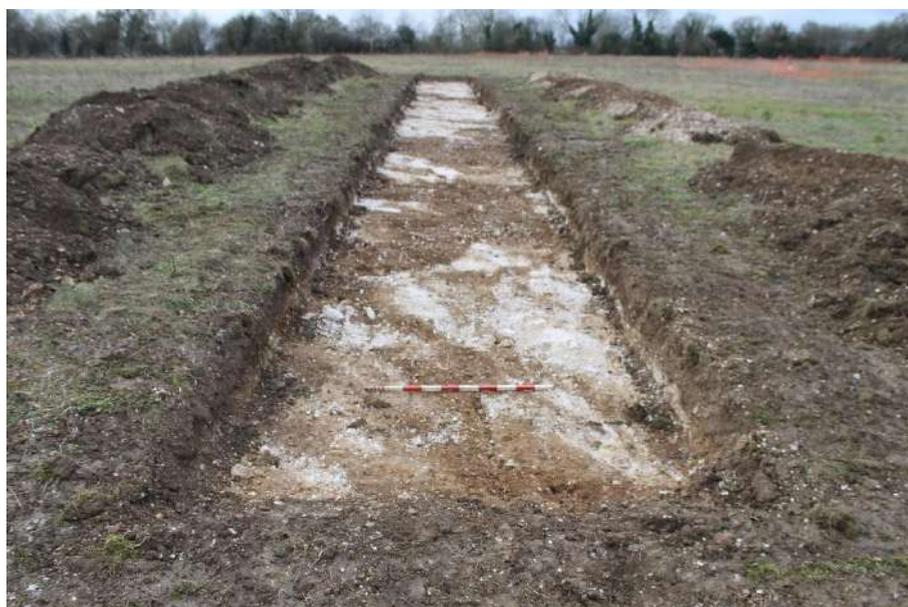
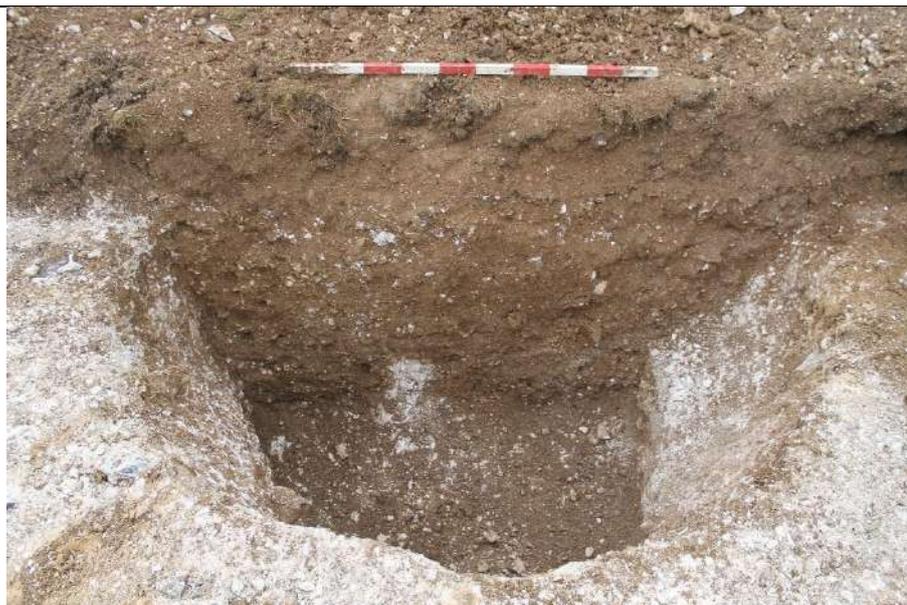
Trench 105 Plate 1

Tr 105
 Plate 1:
 Looking southwest
 1m scale
 Plate 2:
 LIA/Early Roman
 Quarry pit [437]
 Looking northwest
 Section 215
 1m scale

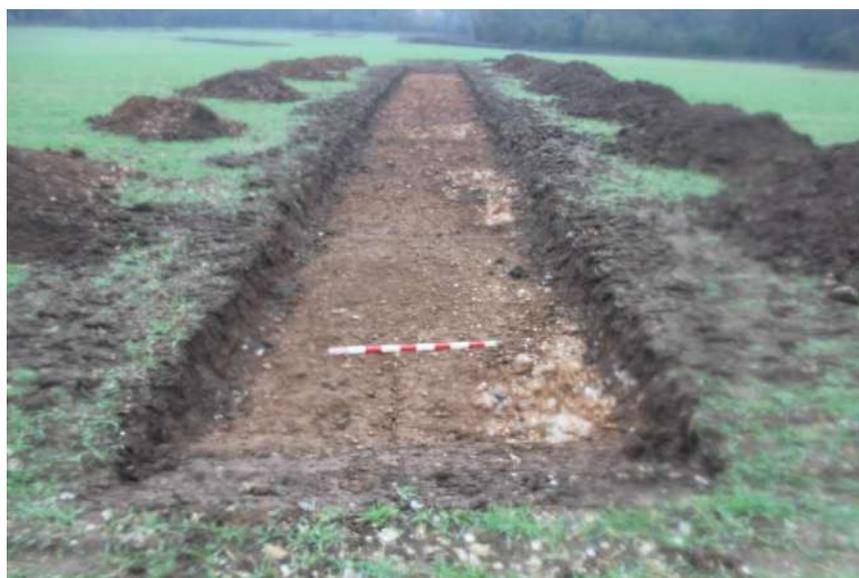
Trench 114 contained natural brickearth that was truncated by postholes [353] (0.45m long, 0.45m wide and 0.11m deep) and [381] (0.6m long, 0.6m wide and 0.14m deep) and threethrow [355] (0.95m long, 0.56m wide and 0.16m deep). These features were identified by the geophys survey. The trench was sealed by modern subsoil and topsoil.

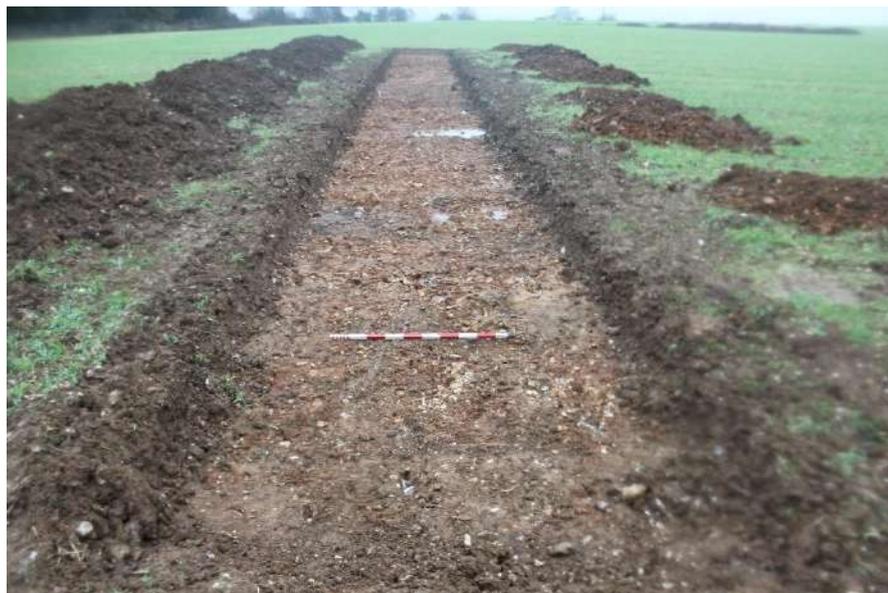
Trench 117 contained natural brickearth that was truncated by postholes [339], [357] and [343] (averaging 0.5m long, 0.39m wide and 0.2m deep). Also cutting the natural were pits [325] (1.11m long, 0.98m wide and 0.21m deep) and [341] (1.05m long, 0.4m wide and 0.23m deep). The geophysical survey suggested a linear feature, however only postholes were encountered. The trench was sealed by modern subsoil and topsoil.

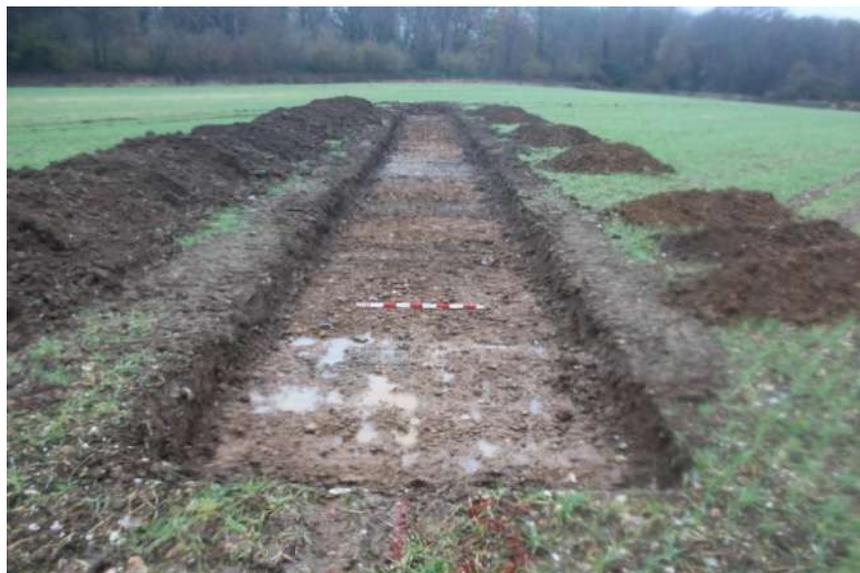
Tr 118
Looking south
1m scale

Trench 118 contained natural brick earth and was truncated by multiple features as the geophysics suggested. The natural was truncated by ditch [346] (2.3m long, 1m wide and 0.17m deep), pits [389] (1.6m long, 1.14m wide and 0.22m deep), [375] (1.4m long, 0.76m wide and 0.4m deep) and [330] (1.1m long, 0.6m wide and 0.18m deep) and posthole [332] (0.4m long, 0.46m wide and 0.12m deep) which were truncated by pit [328]. Pit [330] contained IA pottery and pits [375] and [389] contained IA/Early Roman pottery. The trench was sealed by modern subsoil and topsoil.

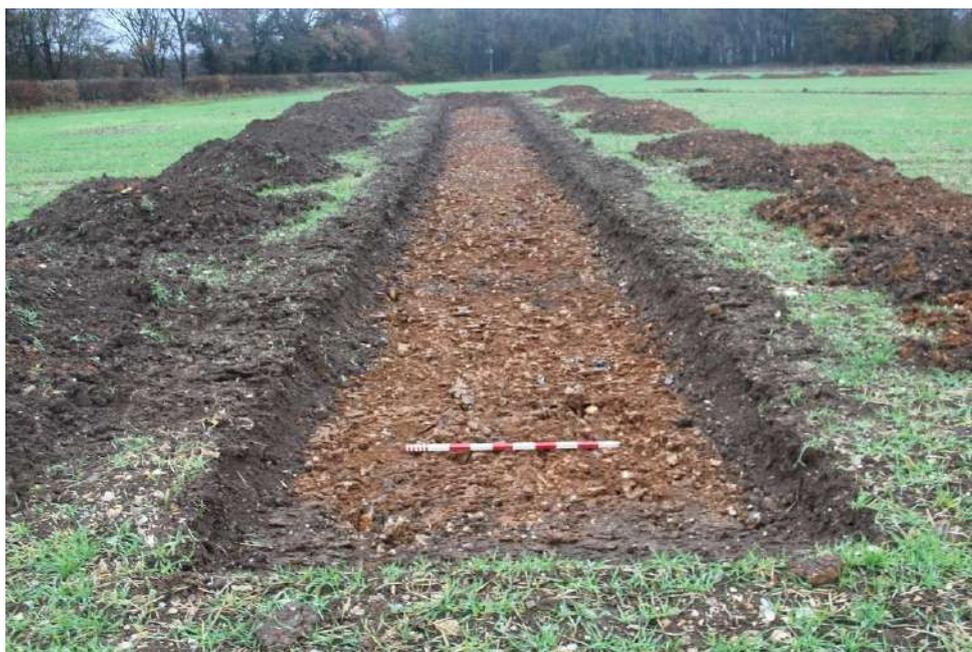
Tr 120
Looking southeast
1m scale

Trench 120 contained natural brick earth that was truncated by ditch [396] (2.1m long, 0.75m wide and 0.3m deep), which contained IA pottery, and pit [386] (0.8m long, 0.47m wide and 0.21m deep). The trench was sealed by modern subsoil and topsoil.

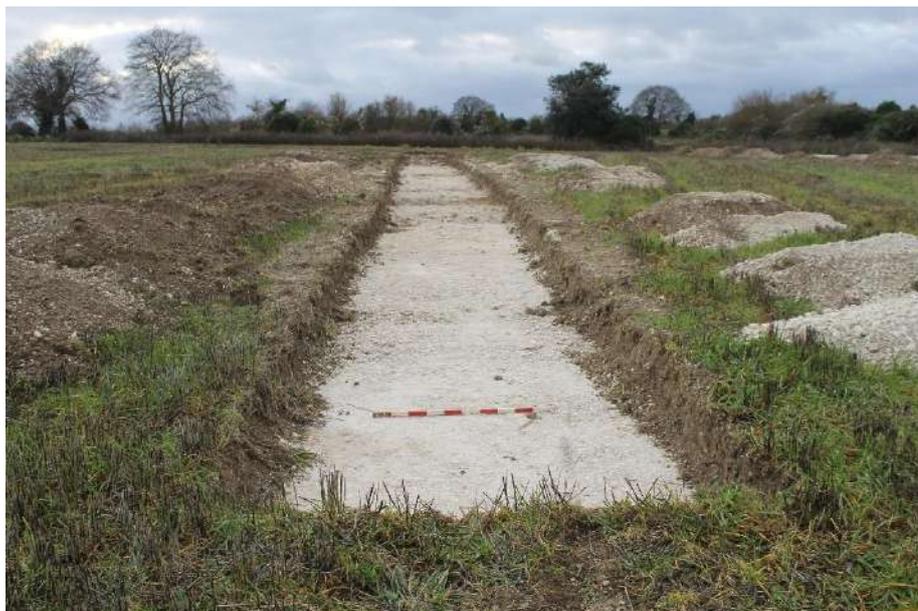
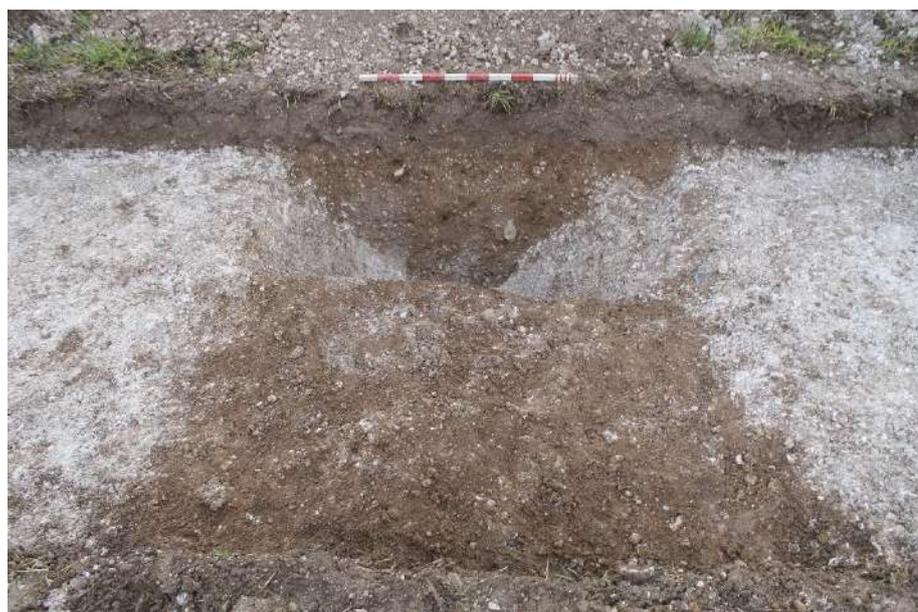
Trench 124 Plate 1

Trench 124 contained a natural chalk deposit that was cut by ditch [312] (2m long, 1.94m wide and 0.81m deep) which was a continuation of ditch [79] in trench 53 and ditch [130] in trench 57 as shown on the geophysical survey. Postholes [324], [250] and [247] (averaging 0.48m long, 0.72m wide and 0.2m deep) were a continuation of a line of postholes found in trench 53. The trench was sealed by modern subsoil and topsoil.
