## 4. Built Heritage

## Appendix 3

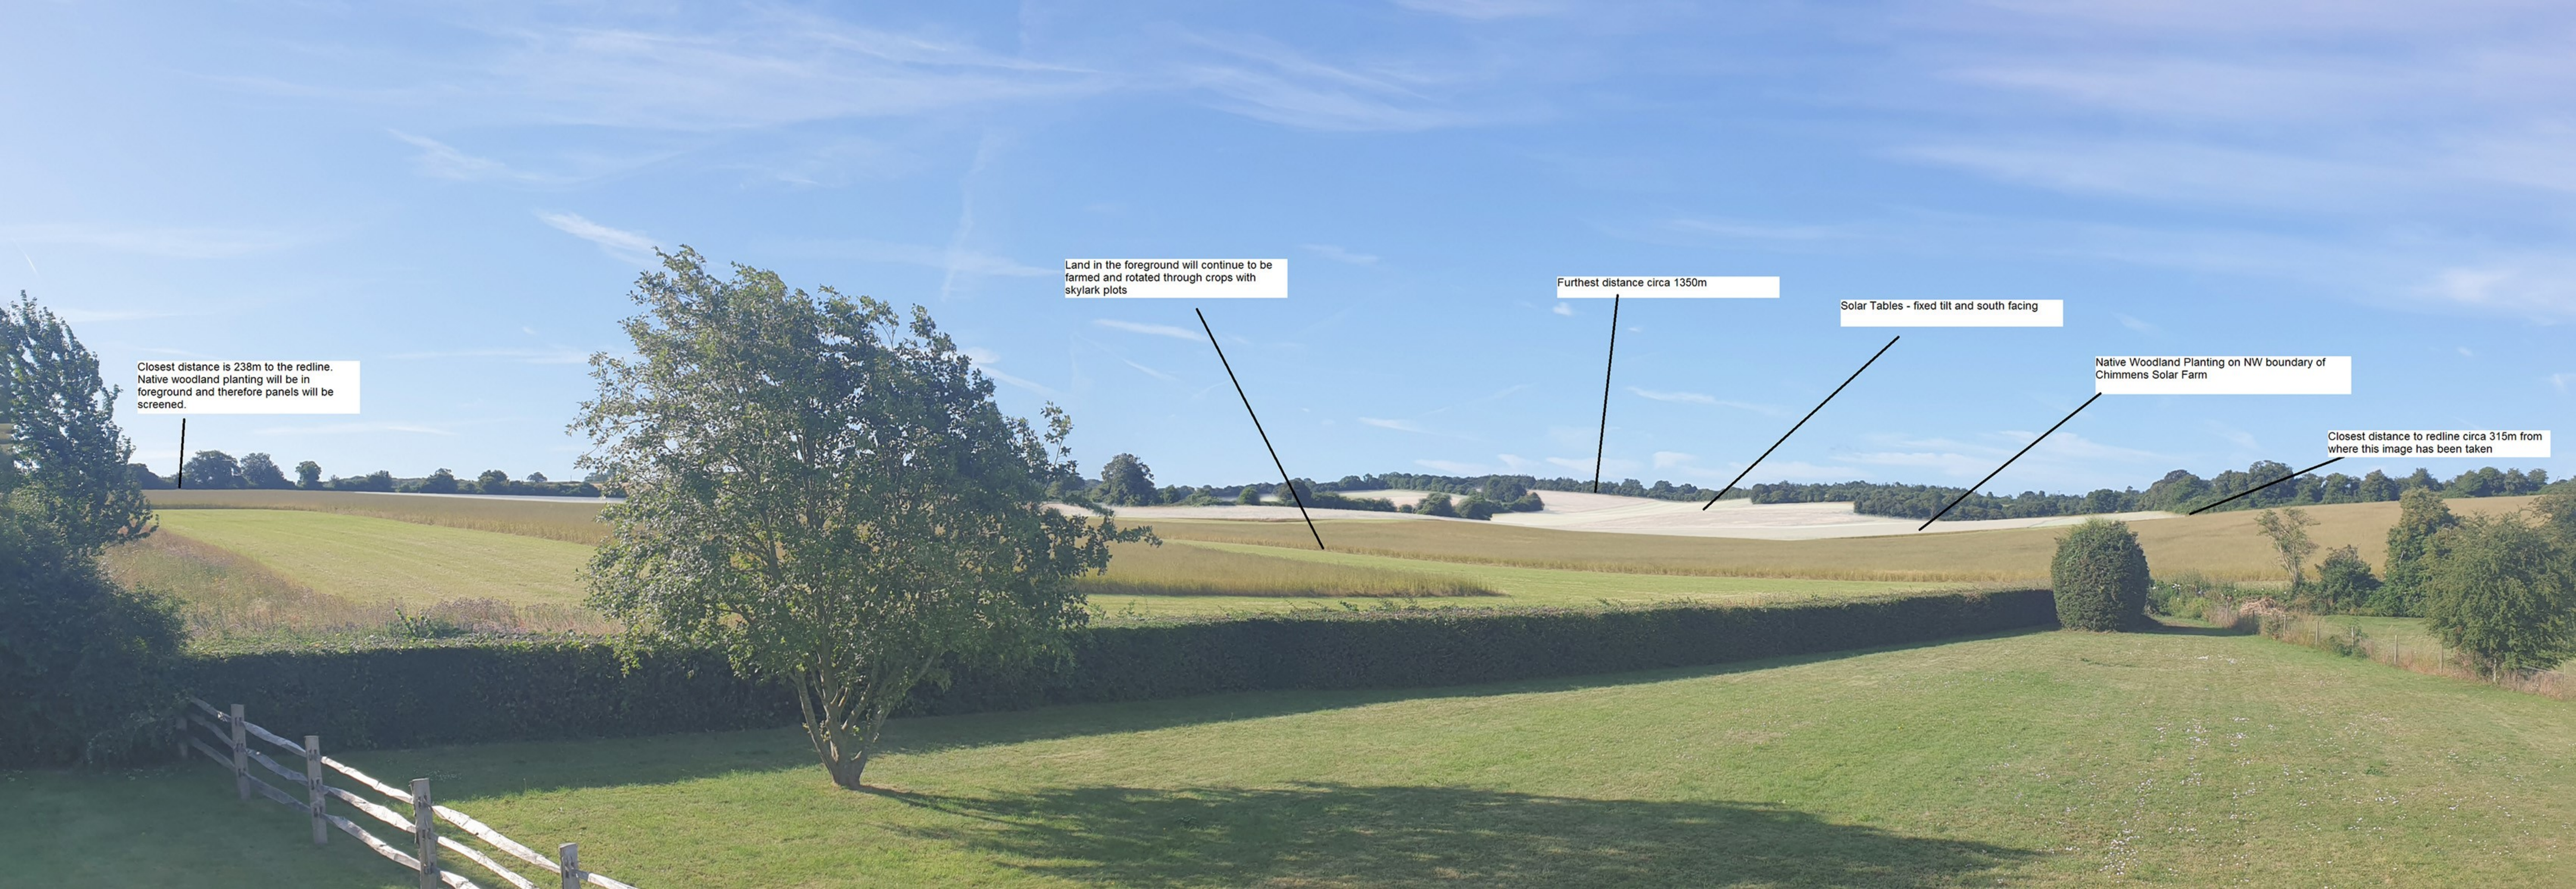
Closest distance is 238m to the redline. Native woodland planting will be in foreground and therefore panels will be screened.

Land in the foreground will continue to be farmed and rotated through crops with skylark plots

Furthest distance circa 1350m

Solar Tables - fixed tilt and south facing

Native Woodland Planting on NW boundary of Chimmens Solar Farm

Closest distance to redline circa 315m from where this image has been taken

- The main elevation of Mussenden Farmhouse faces broadly north and fronts onto Mussenden Lane, although there are views from the side and rear elevation which include views across the site, seen in association with expansive agricultural land not included within the site boundary, as seen in the marked-up photography. The other assets at Mussenden Farm were originally constructed as barns / granaries and therefore any views to / from them with formerly associated agricultural land is considered to be incidental, rather than designed views.

- Views in the direction of the site from Mussenden Farmhouse comprise expansive agricultural land not included within the site boundary, as seen in the marked-up photography (included at Appendix 3).
